Workplace Health and Safety Fatality Report

GRAVEL TRUCK OPERATOR CRUSHED AFTER OVERTURNING IN A CREEK

Type of Incident: Fatality

Date of Incident: December 17, 2009

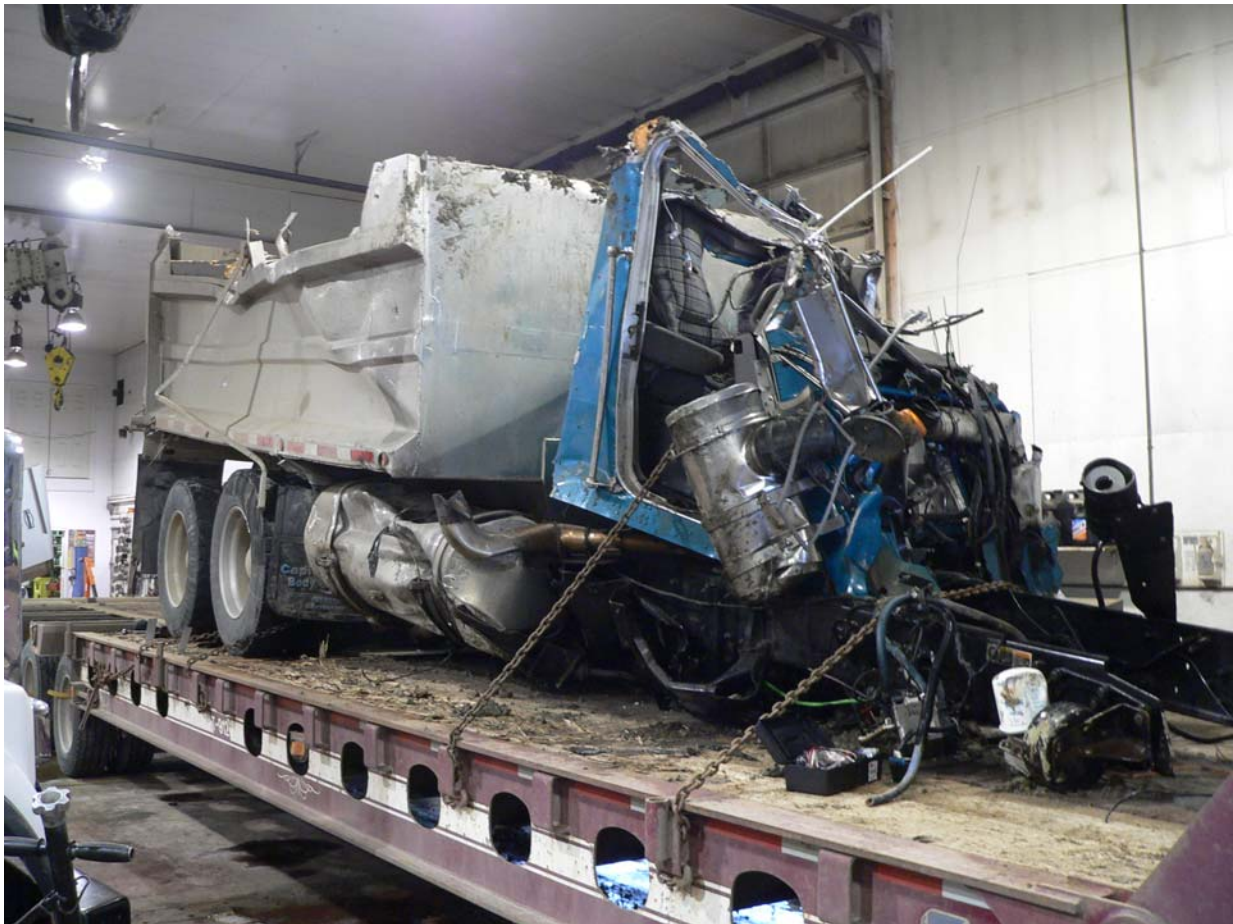
Photograph #1 Shows the Kenworth gravel truck belonging to 1236112 Alberta Ltd. after it was retrieved from the Sundance Haul Road Km 3 bridge creek bed. The truck was brought to a Commercial Vehicle Inspection Shop for examination by the OHS Investigators, Commercial Vehicle Inspection mechanics and a tire expert.

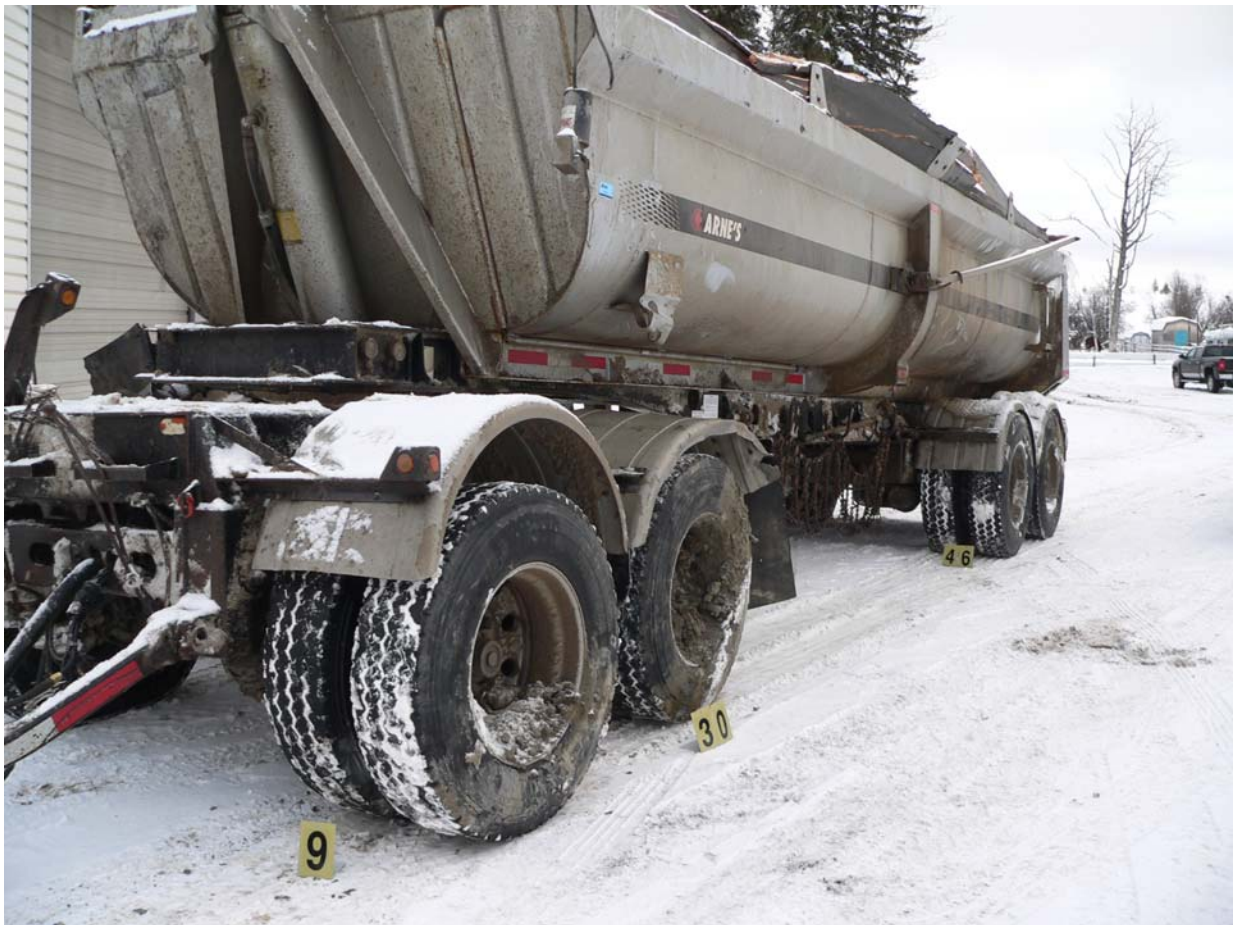
Photograph #2

Shows the Arnes quad wagon gravel trailer belonging to 1236112 Alberta Ltd. that was retrieved from the Sundance Haul Road Km 3 bridge creek bed. This unit is parked in the secure storage compound in Edson, Alberta. This unit was examined by an OHS Investigator, a Commercial Vehicle Inspection Mechanic and a tire expert.

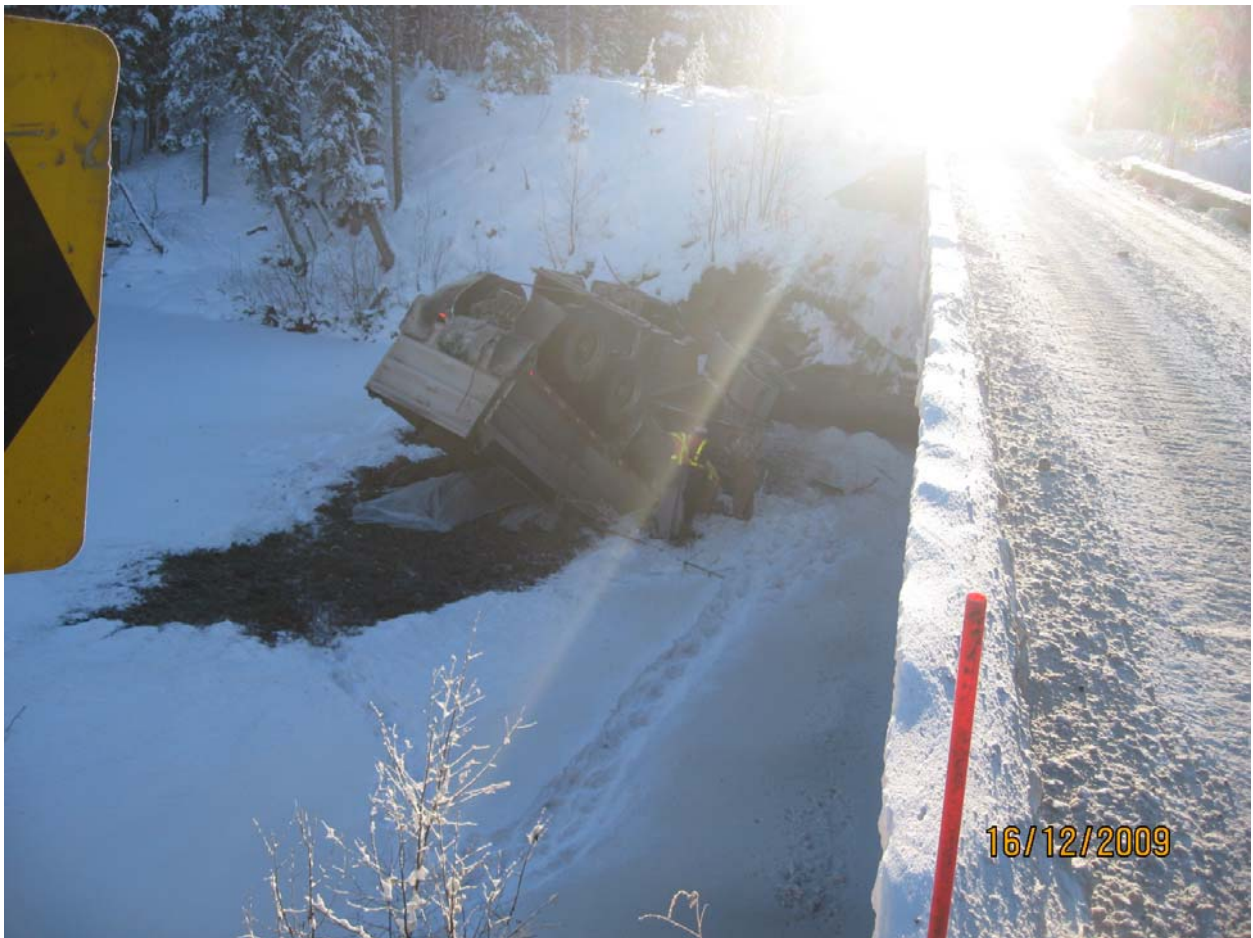
Photograph #3

- 5.2.1 At the time of the incident the sun was shining directly into the eyes of the Urgel Contracting Ltd's service truck operator as evidenced by witness statements and a picture of the scene of the incident shortly after the crash. (Attachment C – Photograph 3)

Shows the crash site shortly after the incident occurred. This photograph was taken by a representative of Husky Oil Operations Ltd. who was at the scene immediately after the incident occurrence. This view shows how the sun would have been in the eyes of the two workers employed by Urgel Contractors Ltd. when they were crossing the Sundance Haul Road, Km 3 bridge at the same time the 1236112 Alberta Ltd's gravel truck and trailer were approaching the bridge from the opposite direction.

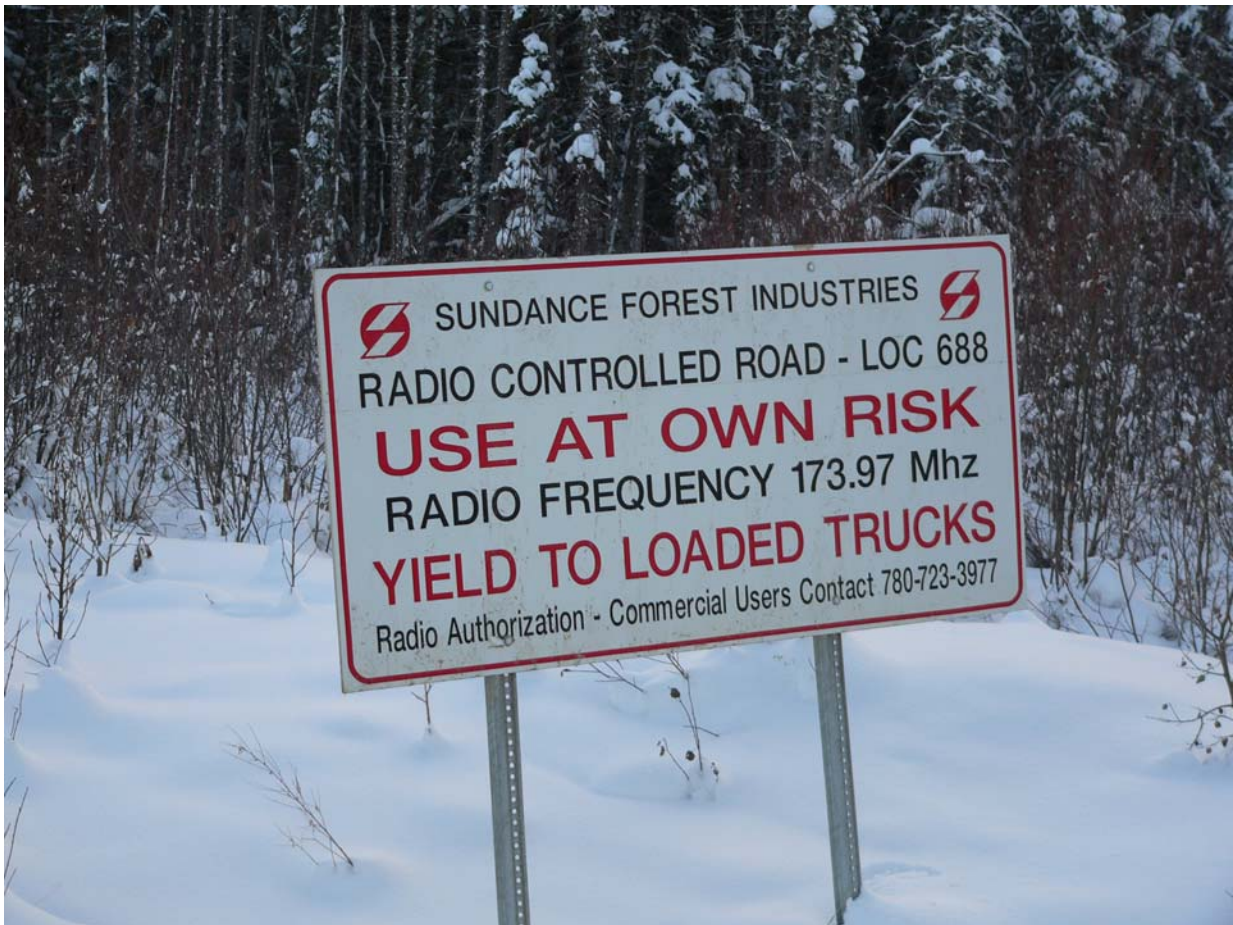
Photograph #4

Shows one of the signs at the entrance to the Sundance Haul Road from Highway 47. This sign indicates mandatory use of radios on this road and also requires that all vehicles yield to loaded vehicles coming out of the forest.

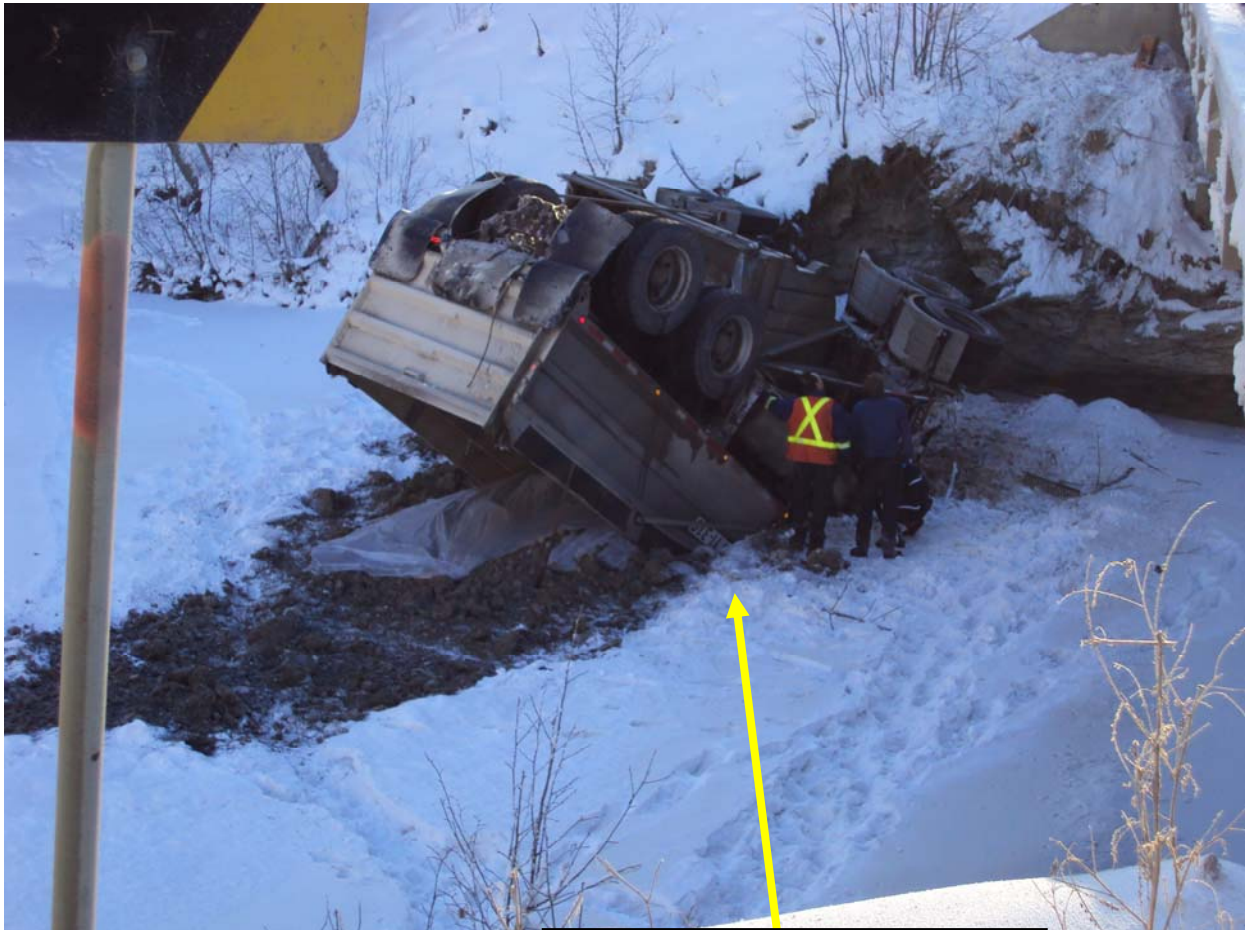
- 6.7 When the Urgel Contracting Ltd's Service Truck was approximately three quarters of the way across the Km 3 bridge, traveling southwards, both the Driver and his Assistant saw the 1236112 Alberta Ltd. Gravel Truck coming around the bend in the road approaching the south entrance to the Km 3 bridge. They both stated that they saw the truck and trailer wheels lock up and start skidding sideways. The Urgel Contracting Ltd. Service Truck accelerated across the remainder of the bridge and pulled over to the ditch and parked. They stated that they watched the 1236112 Alberta Ltd's Gravel Truck travel past them and go over the embankment into the creek. They both rushed to see if they could help, but the truck was upside down and the cab had broken through the ice and was submerged in the creek. (Attachment C, Photograph 5)

- 7.1.1 On December 17, 2009 the 1236112 Alberta Ltd's Gravel Truck Operator received fatal crush injuries when his truck left the one-lane haul road, went over an embankment, overturned, and became submerged in a creek after breaking through the ice. (Attachment C, Photograph 5)

The whole front of the gravel truck had broken through the ice and was submerged in the creek.

Photograph #5 Shows the aftermath of the 1236112 Alberta Ltd's gravel truck and trailer going over the south side embankment of the Sundance Haul Road, Km 3 bridge. This view was taken by an RCMP member shortly after the incident and before the truck was moved by heavy equipment to try to free the truck operator.

The south approach to the Km 3 bridge is just behind the grove of trees past the power generator seen here beside the road.

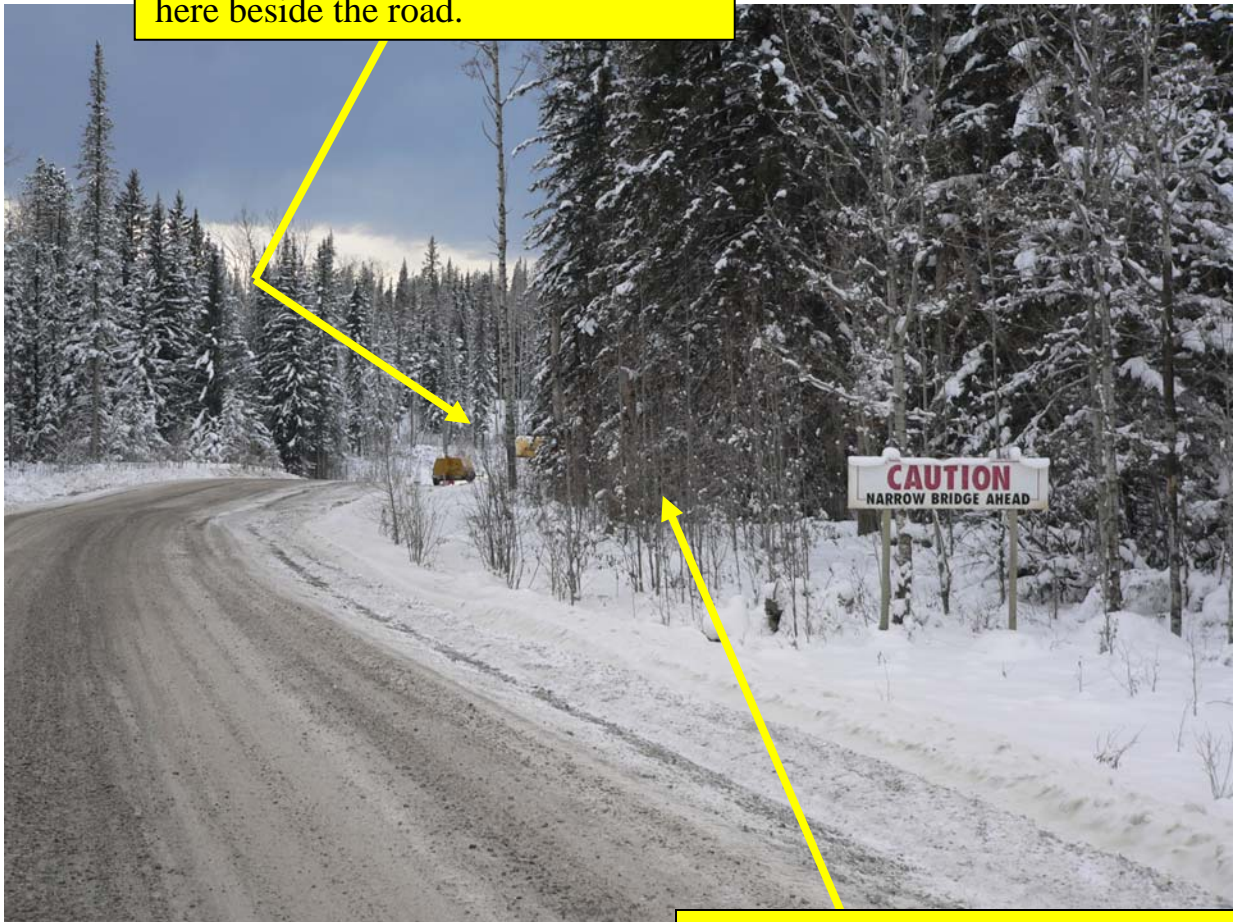
- 7.2.1 There was an S bend in the Sundance Haul Road just prior to the south entry point at the Km 3 bridge. There were no speed reduction signs in this area to warn travelers to slow down due to possible traffic on the Km 3 bridge. Witnesses to the incident stated they saw the Truck Operator lose control of the 1236112 Alberta Ltd's truck and trailer when it came around the bend approaching the Km 3 bridge while he was trying to slow down by applying the brakes. (Attachment C, Photograph 6)

- 7.2.2 There were trees blocking the view just before the approach of the Km 3 bridge for drivers proceeding northward on the Sundance Haul Road. A vehicle on the one lane bridge could not be seen until just before the approach to the bridge. During the time just prior to the incident there was a vehicle on the Km 3 bridge when the loaded gravel truck owned by 1236112 Alberta was approaching the south entry of the bridge. The Urgel Contracting Ltd's Service Truck Operator sped up and exited the bridge before the loaded Gravel Truck arrived at the approach. The Gravel Truck Operator would have had very little time to slow his vehicle. (Attachment C, Photograph 6) The Gravel Truck Operator was familiar with the road as he had travelled it many times in the past weeks.

These trees block the view of the Km 3 bridge when traveling in the S bend going northward.

Photograph #6 Shows a view that would have been seen by the 1236112 Alberta Ltd's truck operator when he was in the S bend driving northwards and approaching the Sundance haul Road Km 3 bridge. The trees at the corner of the right turn are blocking the view of the bridge. Any traffic on the bridge would not be seen by a driver from this position.

8.2.2 Sundance Forest Industries Ltd. installed additional signage on the south approach to the Km 3 bridge, on the Sundance Haul Road, warning of a curve ahead and speed slowdown for the bridge. The trees on the S curve on the south side of the Km 3 bridge were removed to allow for better visibility for travelers approaching the Km 3 bridge from the south, and thus allow them to see if there was any traffic on the one lane bridge. A hazard assessment for the Sundance Haul Road that had recently been produced was supplied to the OHS Investigator for review. Sundance Forest Industries sent a notice to all the stakeholders who had a Road Use Agreement outlining the details of the incident and the corrective measures that had been initiated along with a copy of the Road Use Agreement rules, with additional cautionary comments.

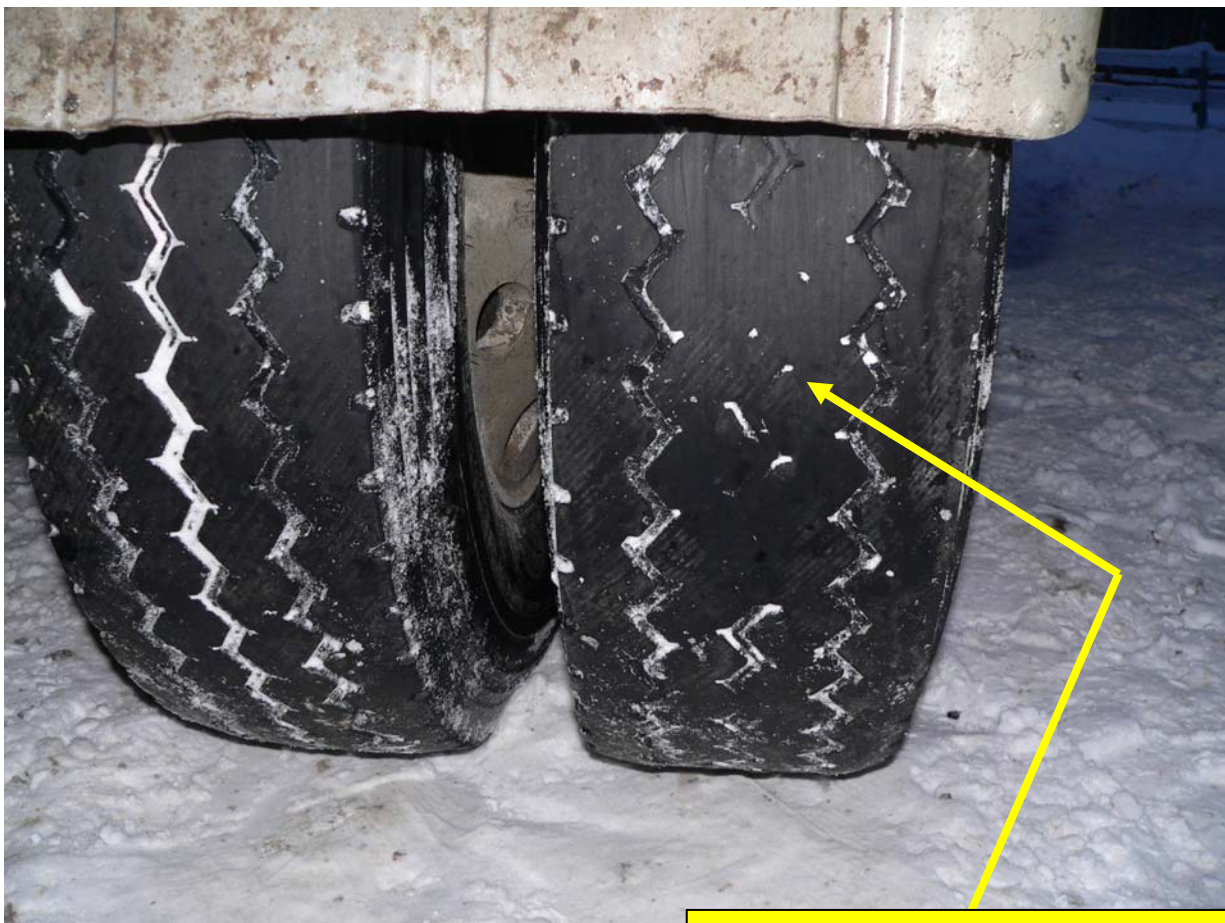
- 7.2.4 The 1236112 Alberta Ltd's gravel truck and quad wagon trailer had a majority of tires that were significantly worn. The tires without grip lugs had little traction ability for slippery roads. The Sundance Haul Road was hard packed snow that was gravelled but had slippery sections.

- 7.2.5 A mechanical inspection of the 1236112 Alberta Ltd's truck and trailer found the brakes in a condition that would pass inspection, but also found that some of the tires were in poor condition due to tread wear. One tire on the Quad Wagon trailer had no tread left. These tire conditions adversely affected stopping ability and traction to prevent loss of control. (Attachment C, Photograph 7)

This tire had no depth of tread left and would have no traction capabilities on slippery surfaces.

Photograph # 7 Shows the wornout condition of the tires on the Arnes quad wagon gravel trailer belonging to 1236112 Alberta Ltd. See photograph 8 for an example of how tires with good tread pattern should appear. This view shows a rear set of dual tires on the passenger side of the trailer. The photos were taken by an OHS Investigator. Many of the Gravel Truck tires were worn nearly to this level of baldness, with the exception of the front steering axel tires which were in near-to-new condition.

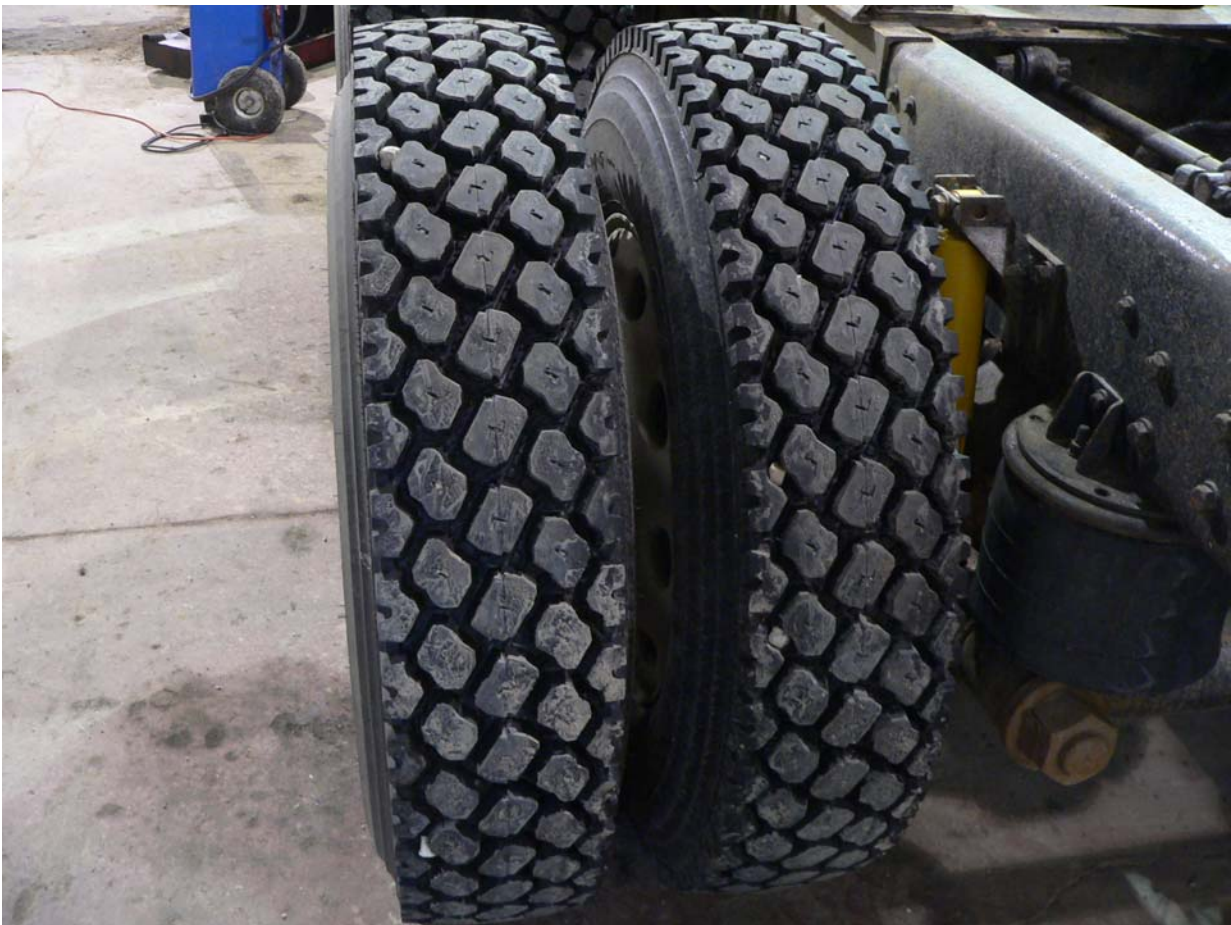
Photograph # 8

Shows a set of newer tires with deep lugs for comparison to the ones on the 1236112 Alberta Ltd's truck and trailer. These tires were on a log haul transport truck that was parked in the Commercial Vehicle Inspection shop where the OHS Investigators were performing an examination of the Kenworth Gravel Truck belonging to 1236112 Alberta Ltd.
