# Workplace Health and Safety Fatality Report

## **WORKER CAUGHT IN CONVEYOR**

Type of Incident: Fatality

Date of Incident: April 13, 2007

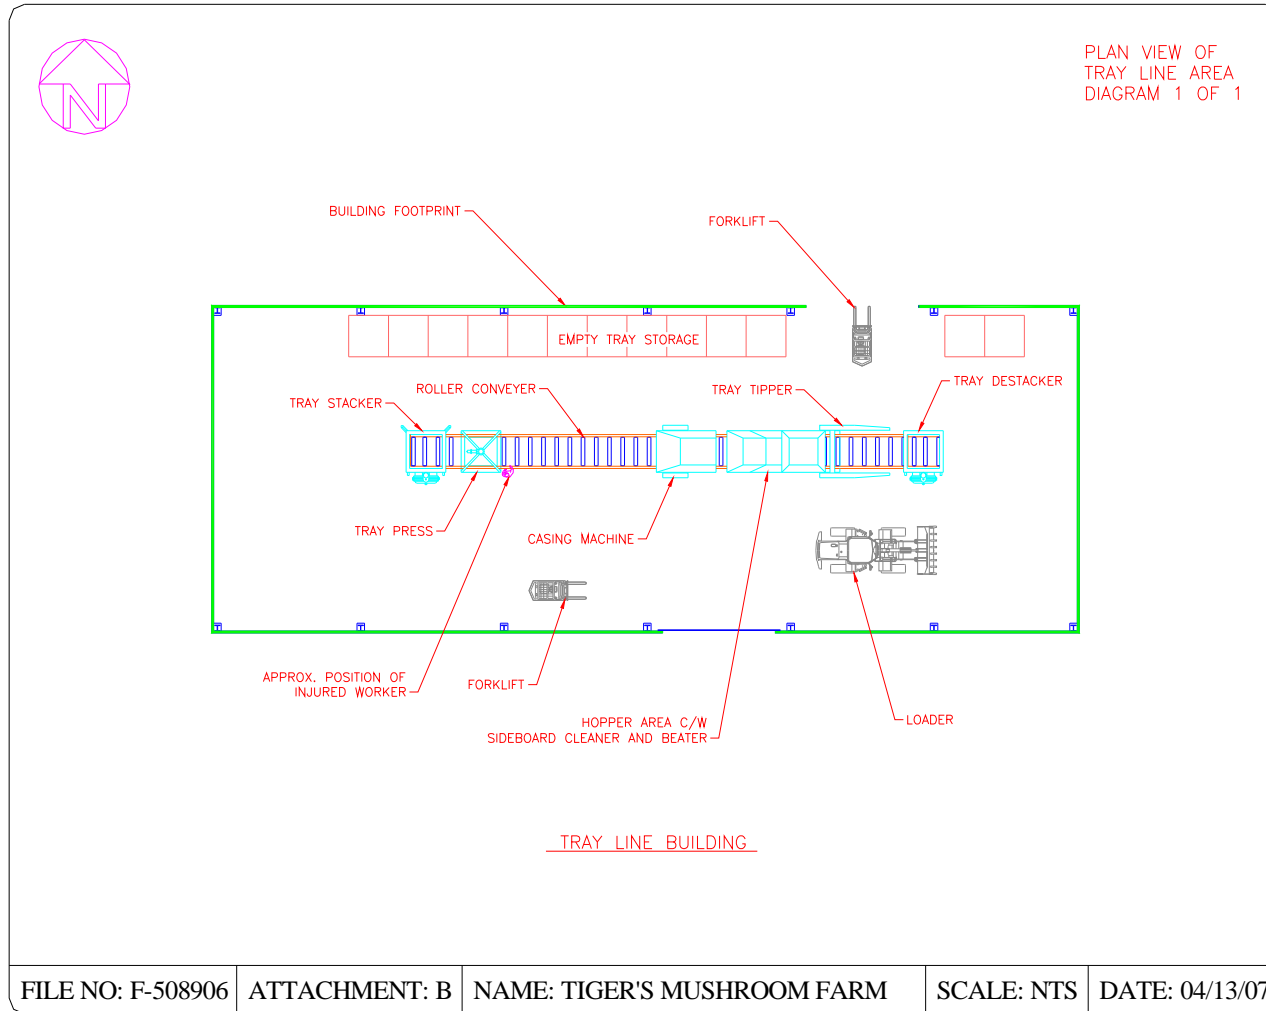
Flow diagram of the mushroom tray line at Tiger Mushroom Farm (2005) Ltd. at the time of the incident.

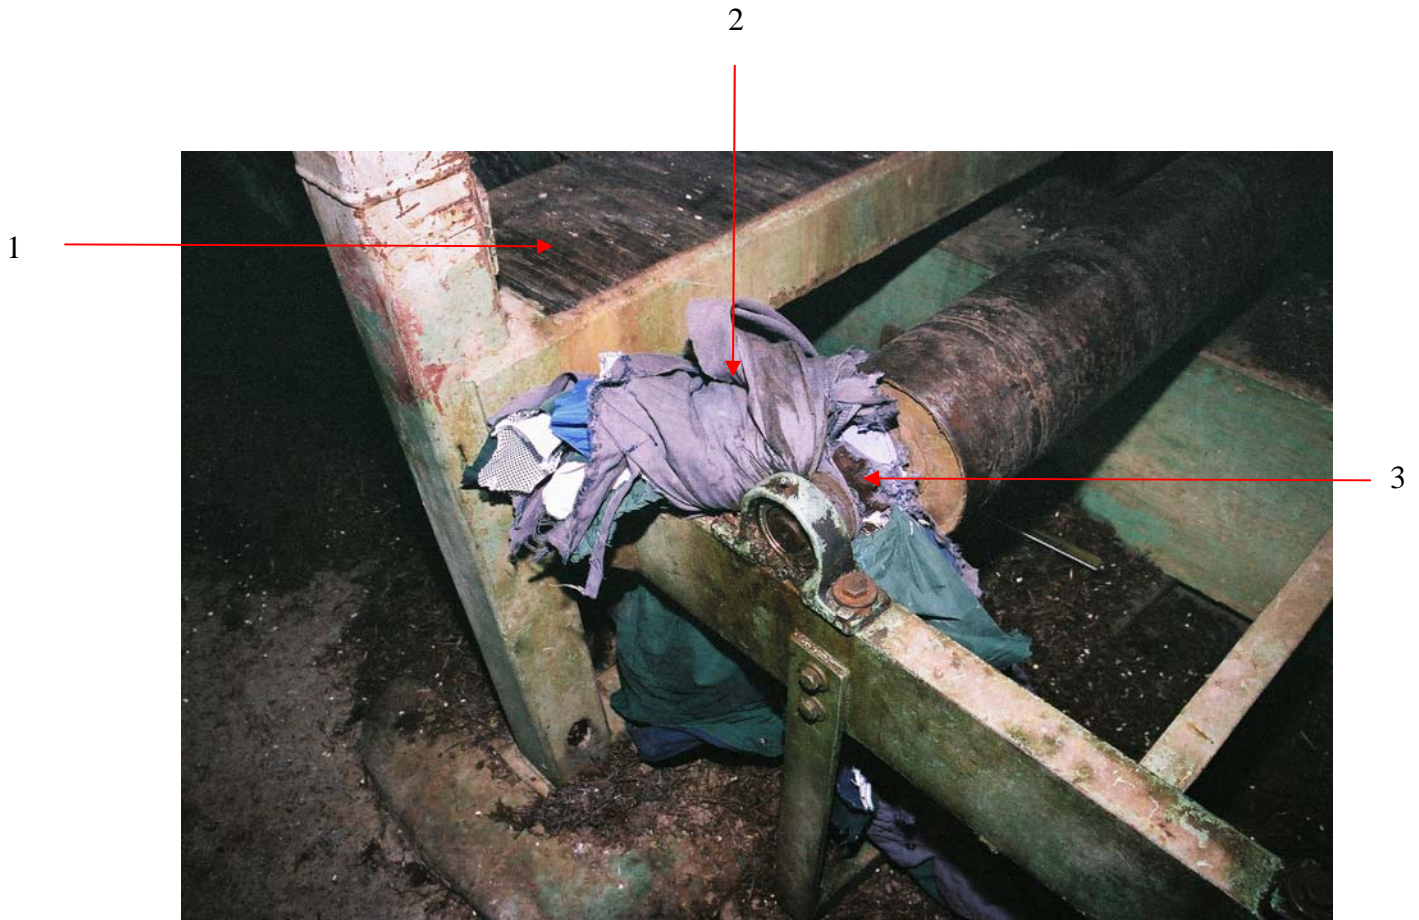
Attachment C  
Photograph 1 of 4

- 7.1.1 Worker 3 was fatally injured when his clothes became caught in the gear teeth of the rollers pulling him into the roller conveyor system.

Photograph 1: Shows the location where worker 3 was found

1. The mushroom tray line press
2. Clothing worn by worker 3 wrapped around the conveyor roller
3. Unguarded rollers with gear teeth

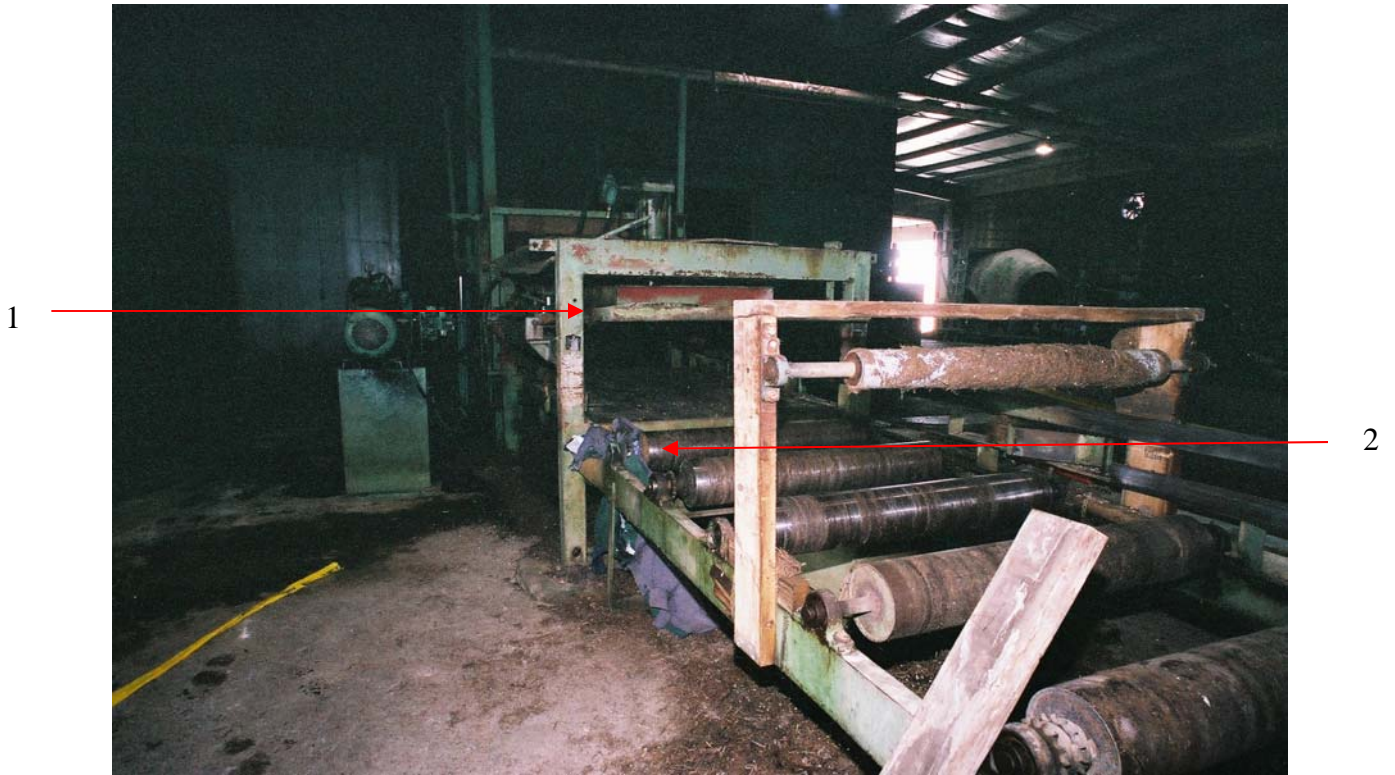
removed. The present owner stated that the safeguard had been removed before he bought the mushroom tray line. Manufacturer's specifications or specifications certified by a professional engineer were not available for the mushroom tray line at the site (Refer to Attachment C – Photographs 2, 3 and 4).

Photograph 2: Shows the press end of the mushroom tray line

1. The compost tray press
2. The location where worker 3 was caught and pulled into the unguarded rollers with gear teeth

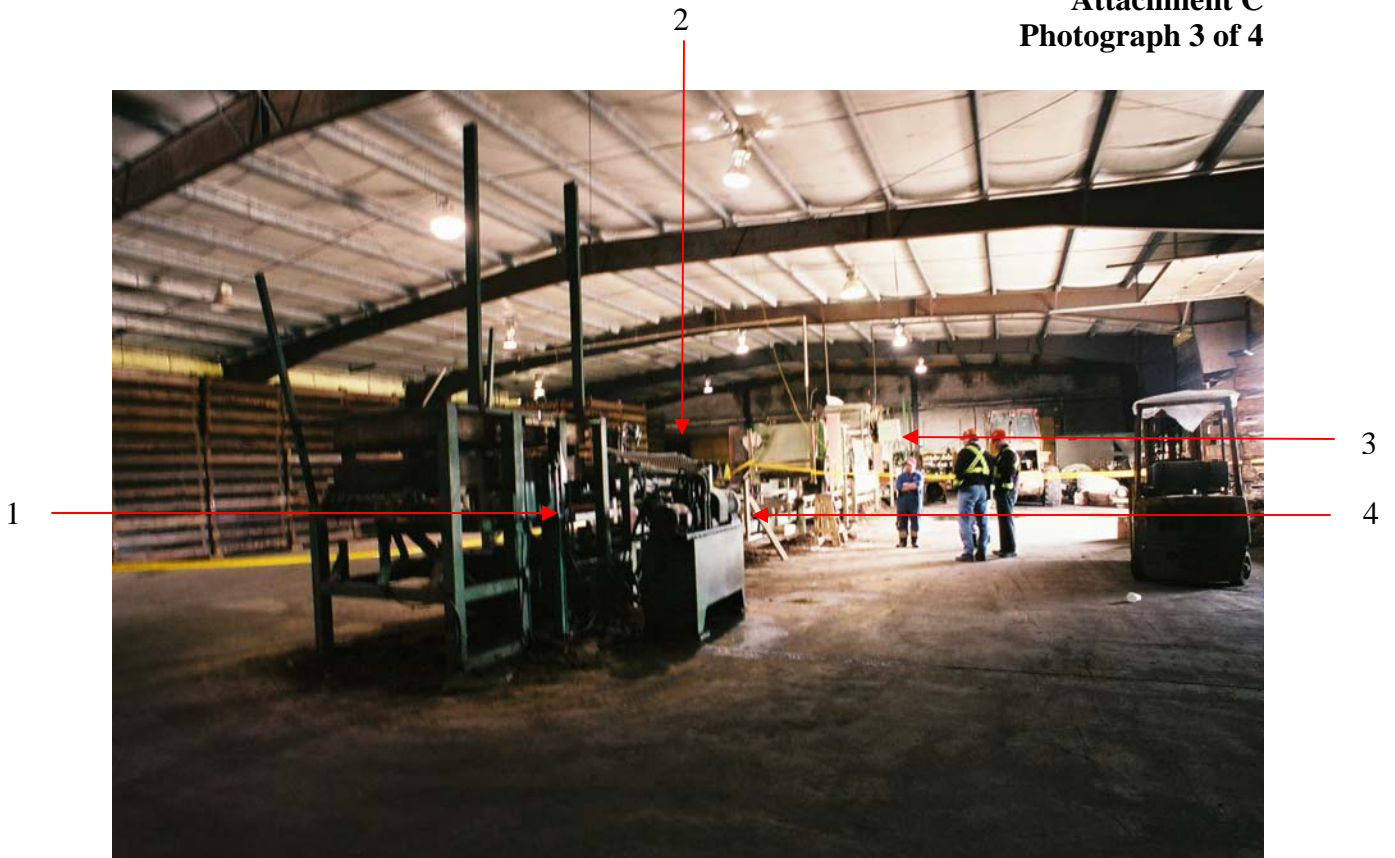
Photograph 3: Shows an overview of the mushroom tray line where the incident occurred

1. The compost tray press end of the mushroom tray line
2. Compost tray press
3. Feed end of the mushroom tray line where the hopper was located
4. Location where worker 3 was caught and pulled into the roller conveyor system

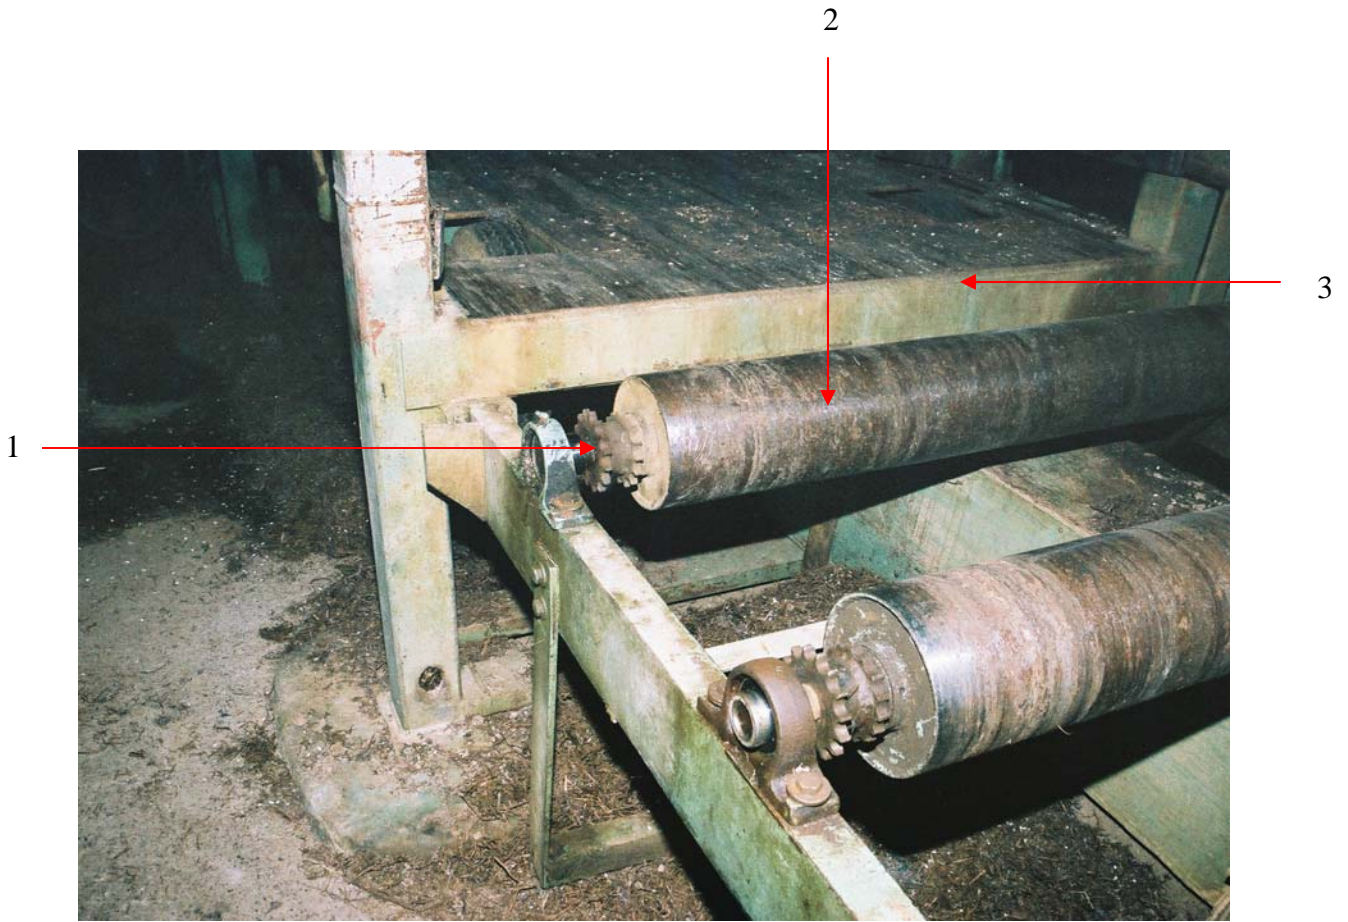
- 7.2.1 The rollers with gear teeth had no safeguards installed.
- 7.2.2 No hazard assessment was conducted to identify the potential or existing hazards associated with the operation of the mushroom tray line.

Photograph 4: Shows the conveyor system unguarded rollers with gear teeth after the clothing of worker 3 was removed

1. The clothes of worker 3 were caught by these gear teeth
2. Roller
3. Compost tray press

- 8.1.2 WHSC issued the following orders to Tiger Mushroom Farm (2005) Ltd.:
  - stop work order to provide safeguards to prevent workers from coming into contact with moving parts of machinery
