# **Workplace Health and Safety Fatality Report**

**Worker Crushed**  
**Date of Incident: September 21, 2007**  
**Type of Incident: Fatal**

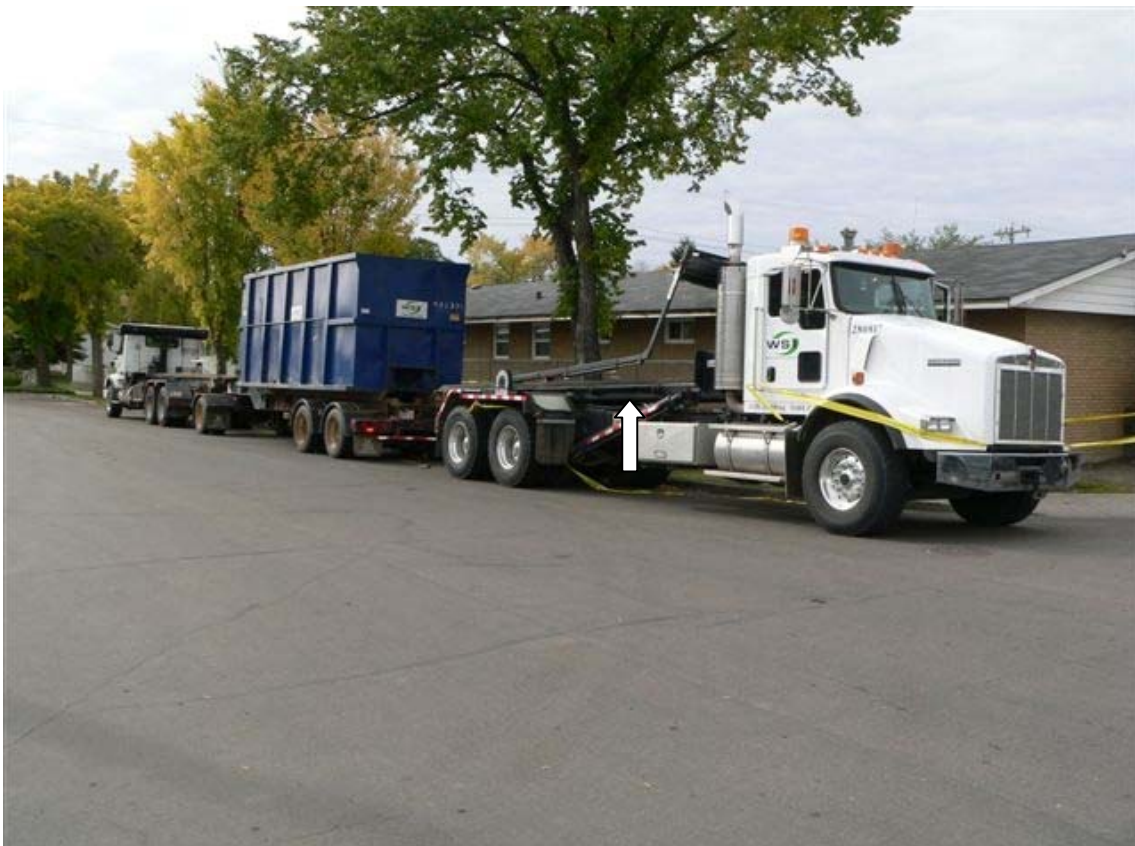
5.2.1 Upon arrival at the scene, the Edmonton Police Service traffic section was on location conducting their investigation. The scene was located near the southwest corner of the intersection of 151 Street and 111 Avenue in Edmonton. The scene consisted of a truck trailer combination with a 28 cubic m bin positioned on the trailer unit. Located approximately 1.2 m north of the end of the trailer was a 2008 Kenworth conventional cab truck with dual, tandem rear axles. This truck was equipped with a set of tilting rails that pivoted at the rear of the truck when the two hydraulic rams located behind the cab were activated. The rails were raised to approximately 5 degrees from the horizontal (Attachment "A" Photograph 1). Both trucks had been turned off.

Photograph #1 Shows the scene with the Kenworth truck on the right of the photograph and the truck/trailer unit with the blue garbage bin on top of the trailer behind the Kenworth truck. The arrow identifies one of the slightly elevated rails; its hydraulic lifting ram is identified by red and white reflective tape just behind the arrow.

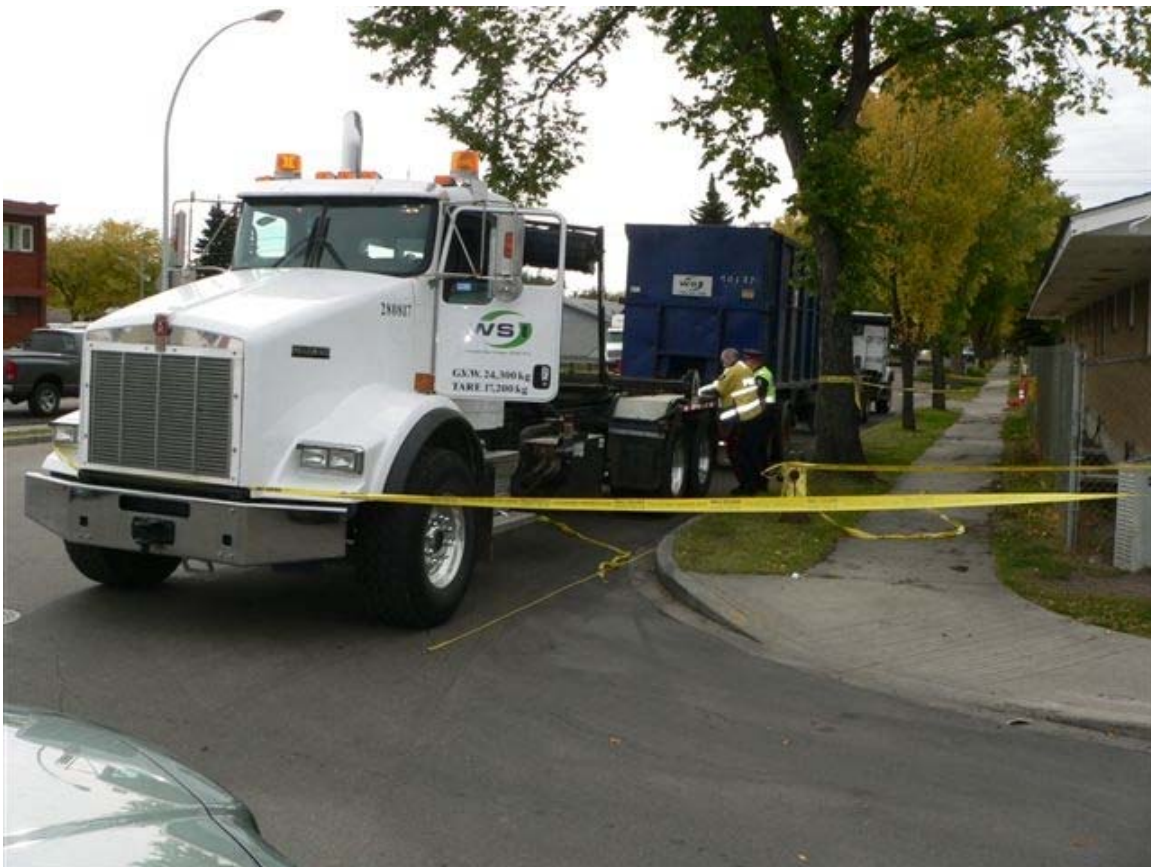
5.1.1.1 The Kenworth truck involved in this incident was a 2008 Construct model; its vehicle identification number was 1NKDL09XX8J934616. Its licensed mass was 23100 kg. (Attachment "A" Photographs 1 & 2).

Photograph #2 Shows the driver's side of the Kenworth truck, looking south on 151 Street.

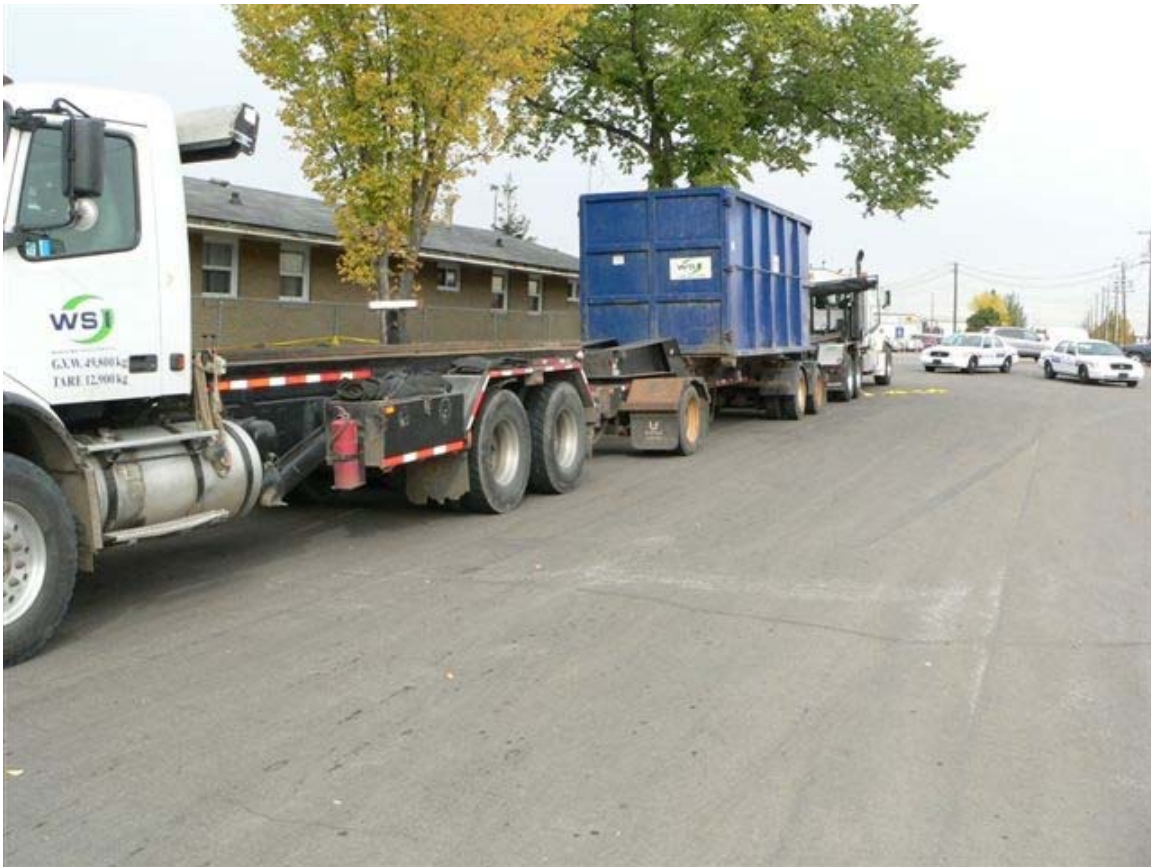
5.1.4.1 The garbage bin involved in this incident was manufactured by Universal Handling Equipment. Its capacity was 28 cubic metres with an empty weight of approximately 2800 kg. The garbage bin measured approximately 6 m long by 2 m high by 2 m wide (Attachment "A" Photographs 1-3).

Photograph #3 Shows the scene looking north on 151 Street. The 28 cubic metre garbage bin is visible on top of the trailer that is connected to the truck the Senior Worker drove to the location before he was fatally injured.

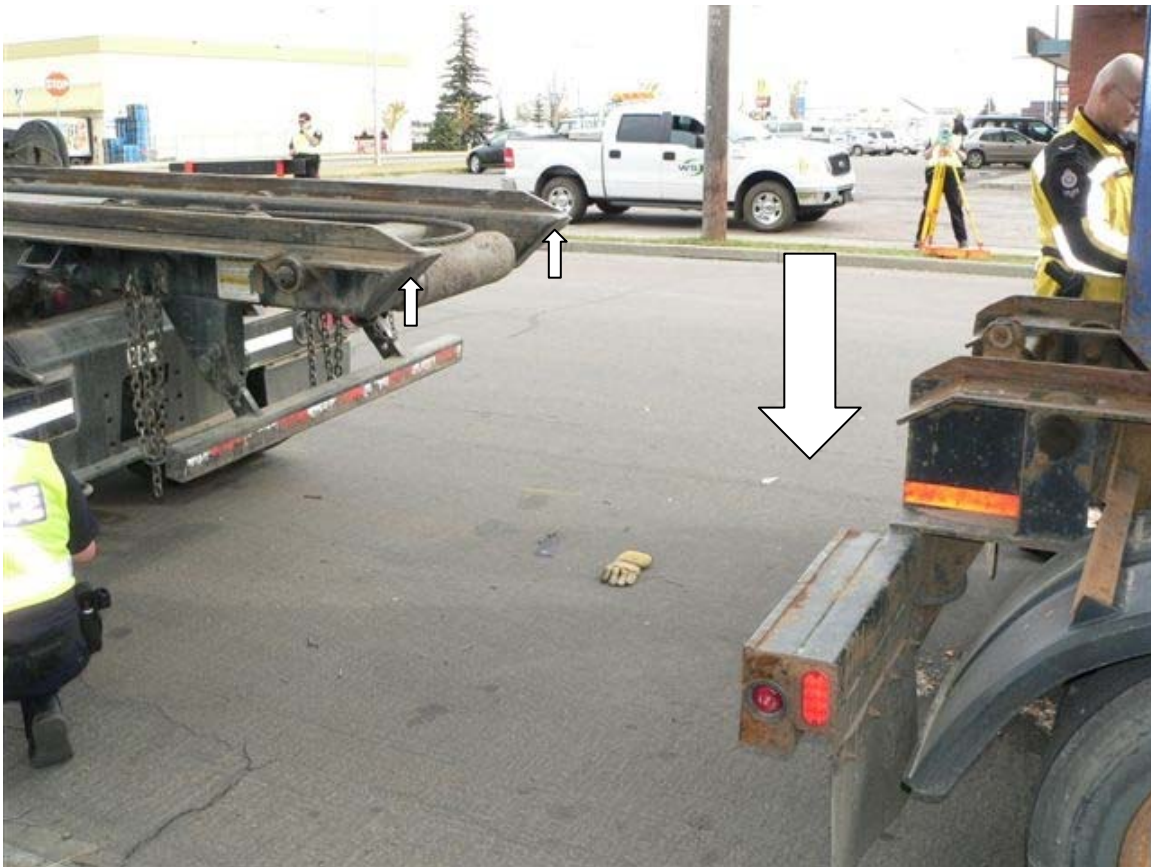
- 7.1.1 The Junior Worker was seated in the driver's seat of the Kenworth truck with his attention focused on activating the pto and related controls. This was necessary to elevate the rails of the unit in order for them to fit under the edge of the garbage bin located on the trailer connected to the Senior Worker's truck, (Attachment "A" Photographs 4 & 5).

- 7.2.5 At this time, the Senior Worker had entered the area between the two trucks to release the hold down mechanism that secured the garbage bin to the trailer connected to his truck. This was necessary to allow the bin to be transferred, (Attachment "A" photograph 4).
- 7.2.6 The Kenworth truck that the Junior Worker was operating, gradually rolled backwards and contacted the Senior Worker, pinning him against the rear of the trailer connected to his truck, seriously injuring him. The road where the rear of both trucks was positioned had a measured grade of between 1 and 2.9 %. The Junior Worker did not realize the subtle grade of the road where the rear of his truck was located. He was also not aware of the location of the Senior Worker as he reversed direction of his truck to approximately 1 m from the rear of the trailer connected to the Senior Worker's truck.

Photograph #4 Identifies the rear of the Kenworth truck on the left of the photograph with the rear of the trailer secured to the truck the Senior Worker was operating visible on the right of the photograph. The large arrow identifies the location where the Senior Worker was standing when he was contacted and pinned by the Kenworth truck. The small arrows identify the ends of the rails that are placed under the garbage bin to facilitate the transfer when the rail mechanism is tilted.

- 8.1.2 Workplace Health and Safety Compliance issued orders for Waste Services (CA) Inc. to submit information to Workplace Health and Safety Compliance and to conduct an investigation into the incident. Waste Services (CA) Inc. was also issued orders to conduct a hazard assessment for transferring a garbage bin from a trailer to a truck and to ensure the safe movement of powered mobile equipment.

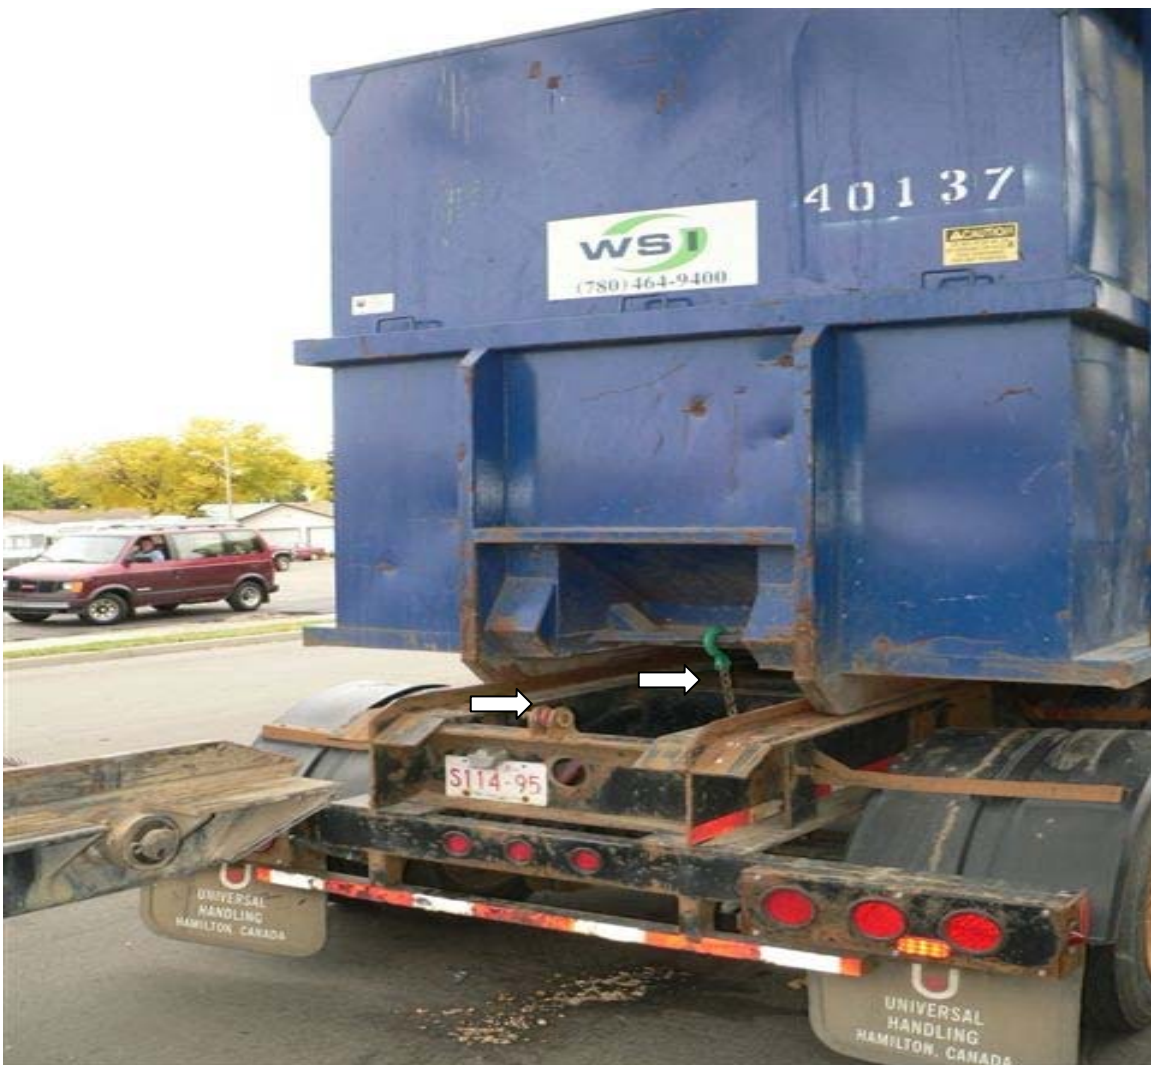
- 6.4 The Junior Worker placed the gear shift of the Kenworth truck in the neutral position while he activated the power take off (pto) unit for his vehicle. During this time the Senior Worker entered the area between the two vehicles and began releasing the hold down mechanism that secured the garbage bin to the trailer. While releasing the hold down mechanism, the Senior Worker was facing away from the rear of the Junior Worker's Kenworth truck, (Attachment "A", Photographs 4 & 5).

Photograph #5 Shows the rear of the trailer that the Senior Worker was pinned against. The arrows identify a portion of the hold down mechanism that he was unsecuring at the time of the incident.
