Workplace Health and Safety Fatality Report

WORKER CRUSHED BETWEEN TRUCK AND TANK

Date of Incident: November 2, 2007

Government of Alberta ■
Employment and Immigration

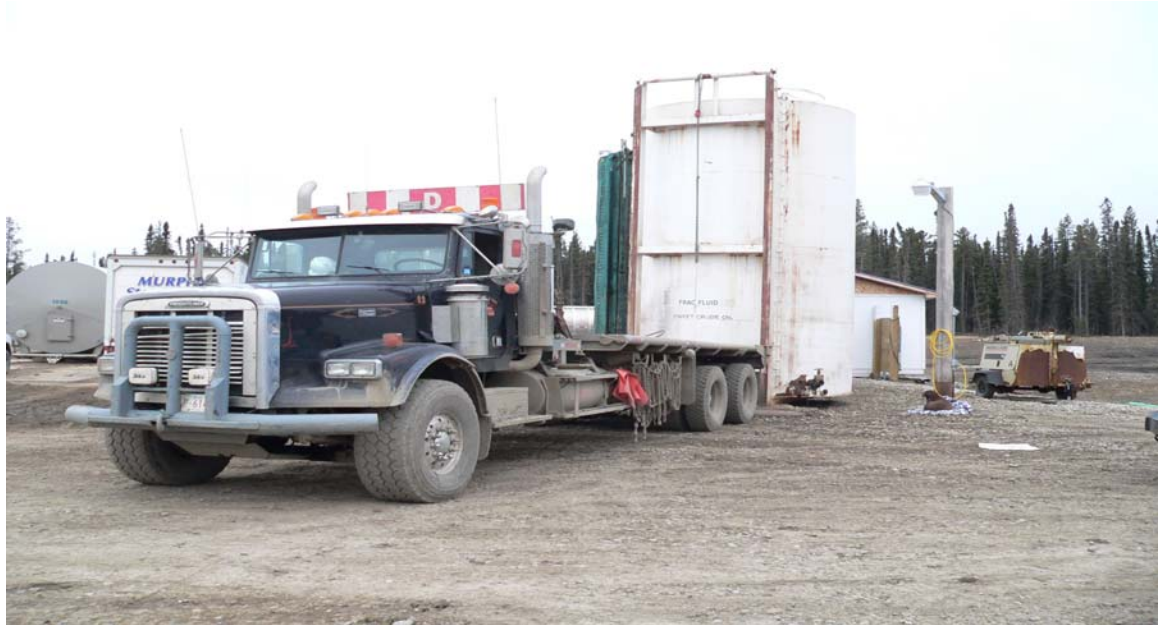
5.1.1 A 1998 Freightliner L120, designed to haul large tanks. (Attachment "A" Photograph #1)

5.1.2 A 400 barrel capacity oil storage tank. (Attachment "A" Photograph #1)

5.2.1 The truck that was involved in the incident was backed up to the tank which was to be loaded on the bed truck. The back-up alarm on the truck was inoperable and the truck driver sounded the horn prior to backing up.

Photograph #1 Shows the truck involved in the incident. The operator was backing up to the tank.

The tank was to be loaded on to the bed truck and moved to another location in the yard.

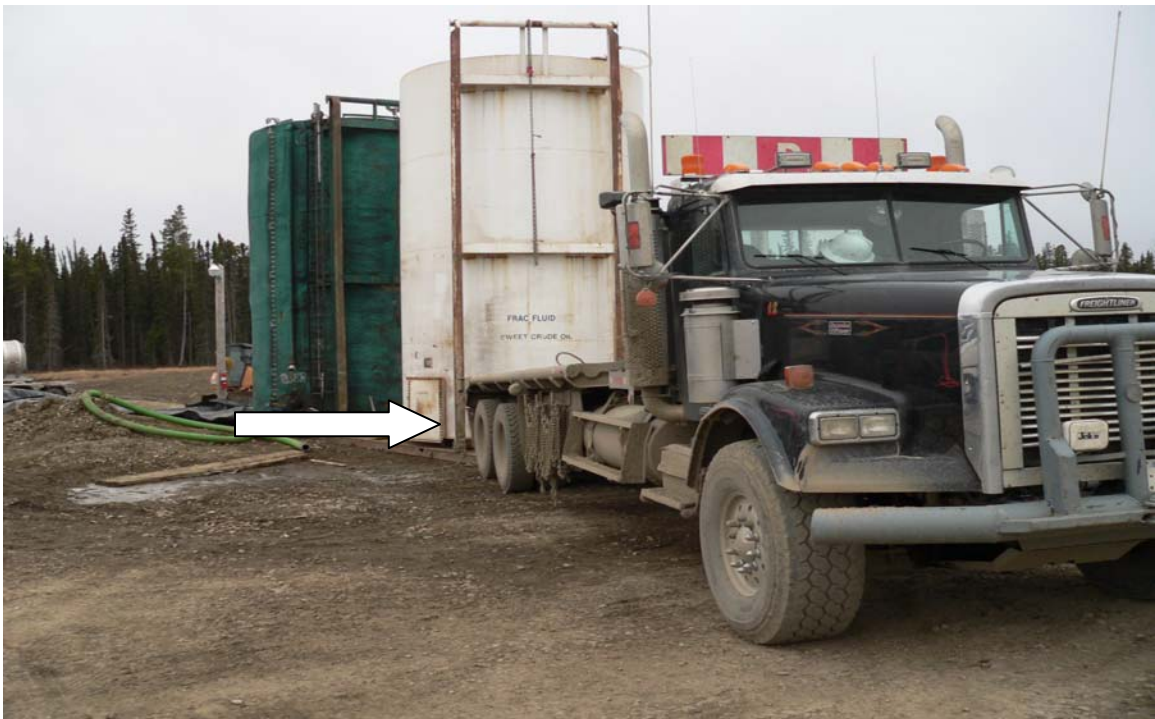
Photograph #2

5.2.2 There were no physical markings on the back of the truck or tank where the worker had been pinned.

- 7.1.1 The owner of Perras Trucking Ltd. was fatally injured when he was pinned between the truck backing up and a stationary storage tank.

The arrow is directed at the location where the worker was pinned in between the rear of the truck and tank.

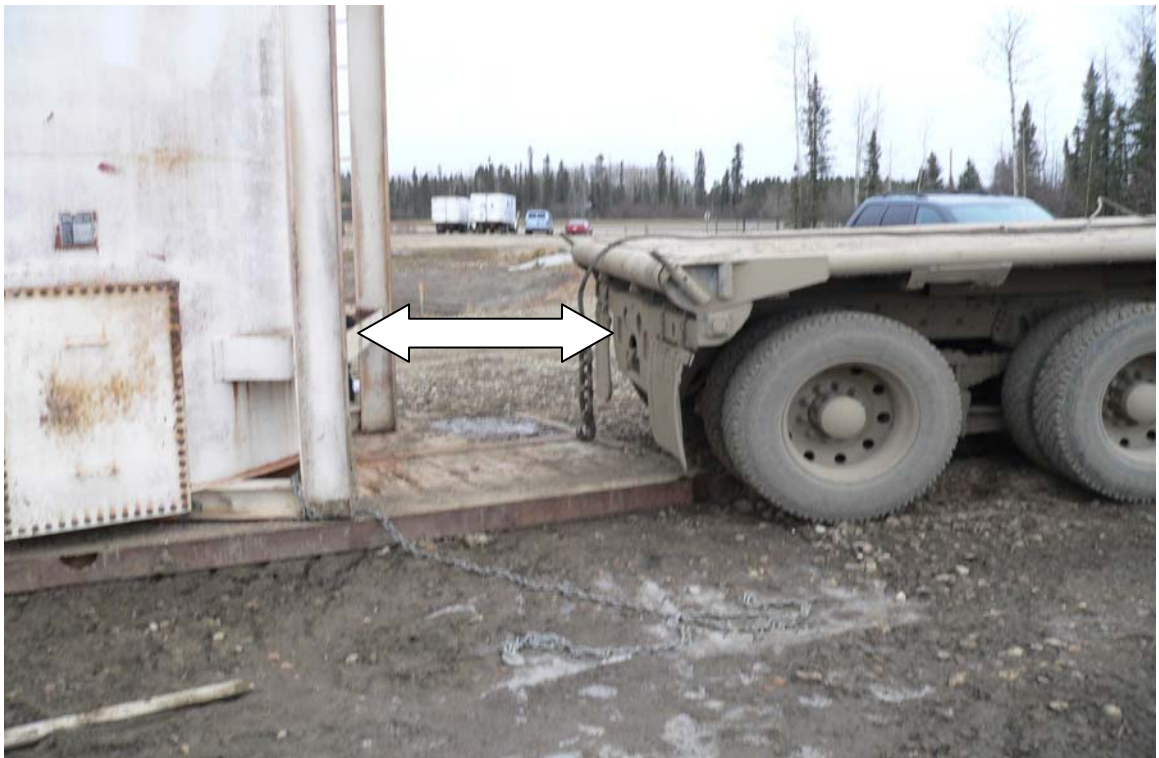
Photograph #3 A close-up view of where the worker was pinned.
