Workplace Health and Safety Fatality Report

WORKER'S HEAD CRUSHED BETWEEN PIPE SPOOLS

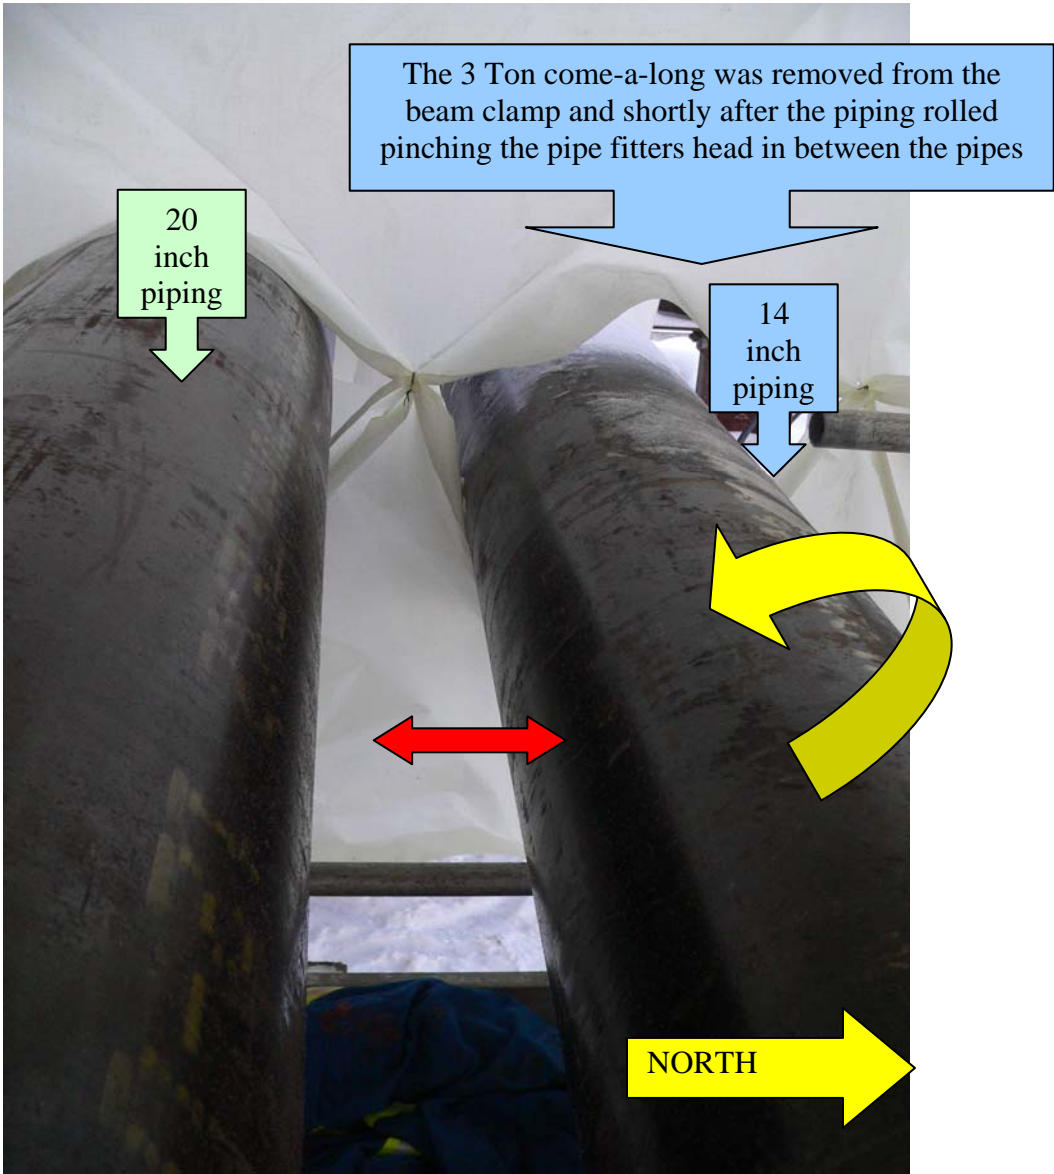
Photograph #6 Looking west; the yellow arrow shows the direction the pipe spool rolled, fatally injuring the worker in between. Both the beam clamp and 3 Ton come-a-long was noted as disturbed from their original positions to care for the injured pipe fitter.

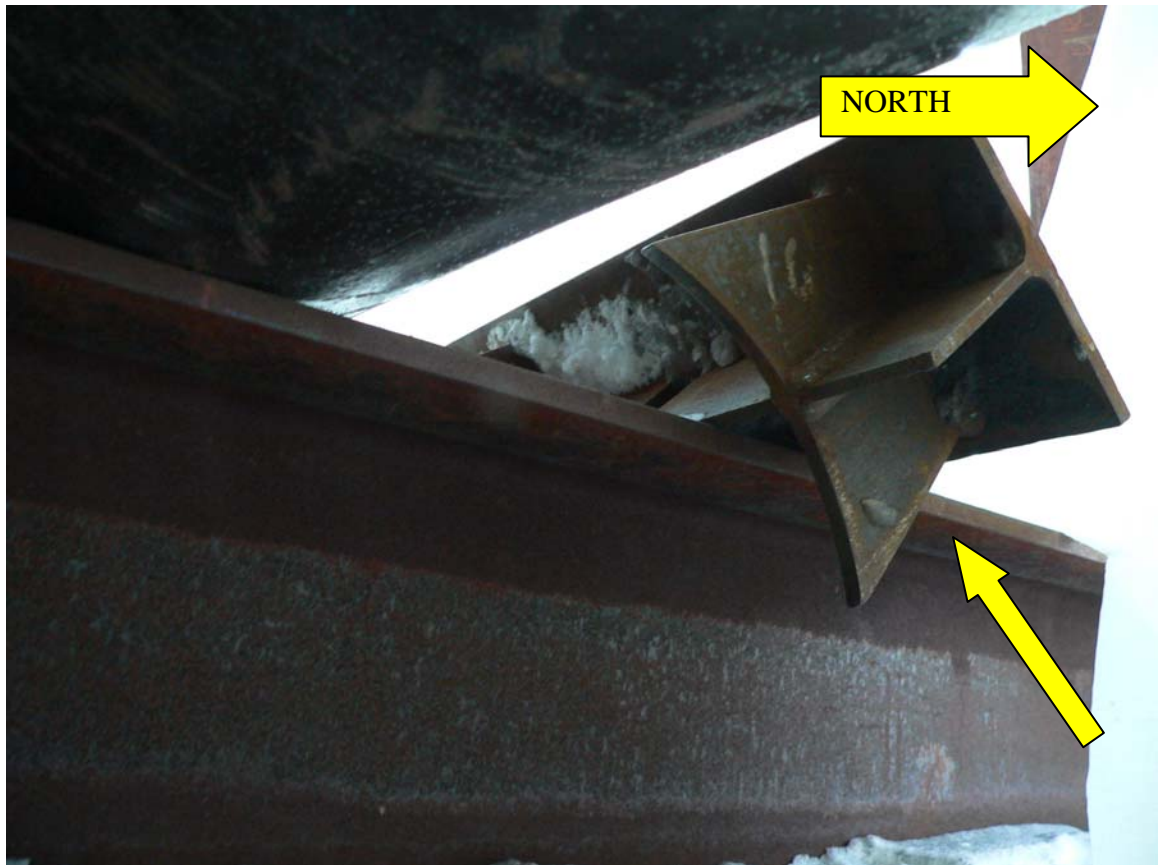
Photograph # 7 Shows the pipe spool dislodged from the cradle of the pipe shoe (yellow arrow). The pipe spool had tipped to the South.

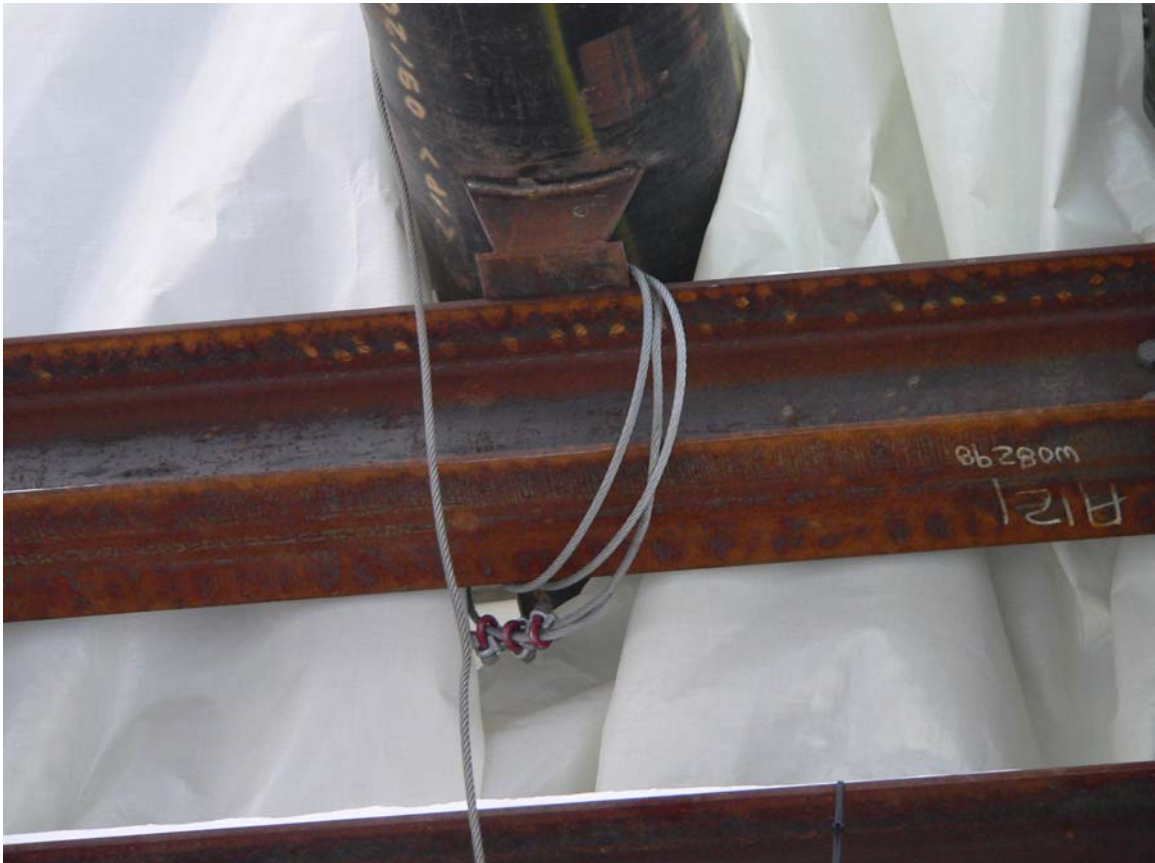
Photograph #9 Shows a method to secure pipe shoes called cable lashing seen being used in the pipe rack #939. These were not observed in use on the 14 inch (355 mm) diameter pipe spool # PW-ABA-14-9353 involved in the incident.

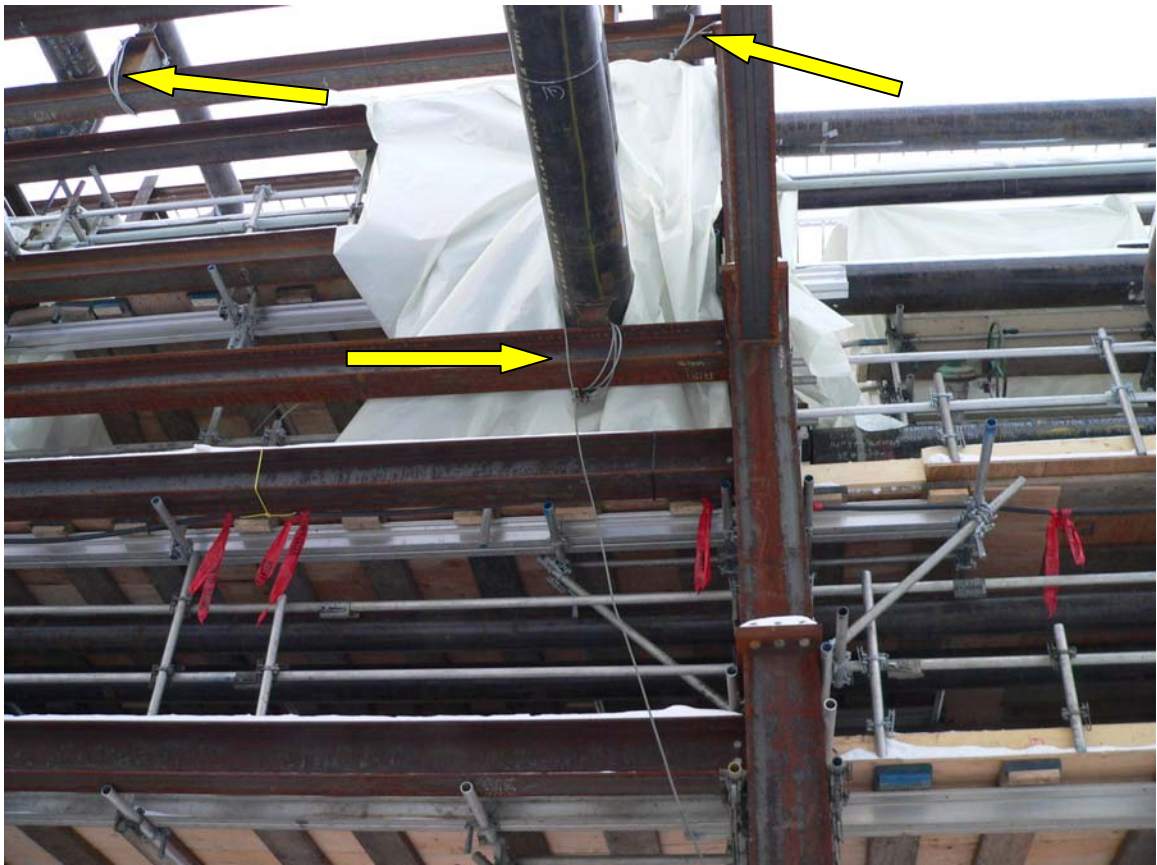
Photograph #10 Shows an expansion loop with various cable lashing used. These were not observed in use on the five pipe spool involved in the incident.

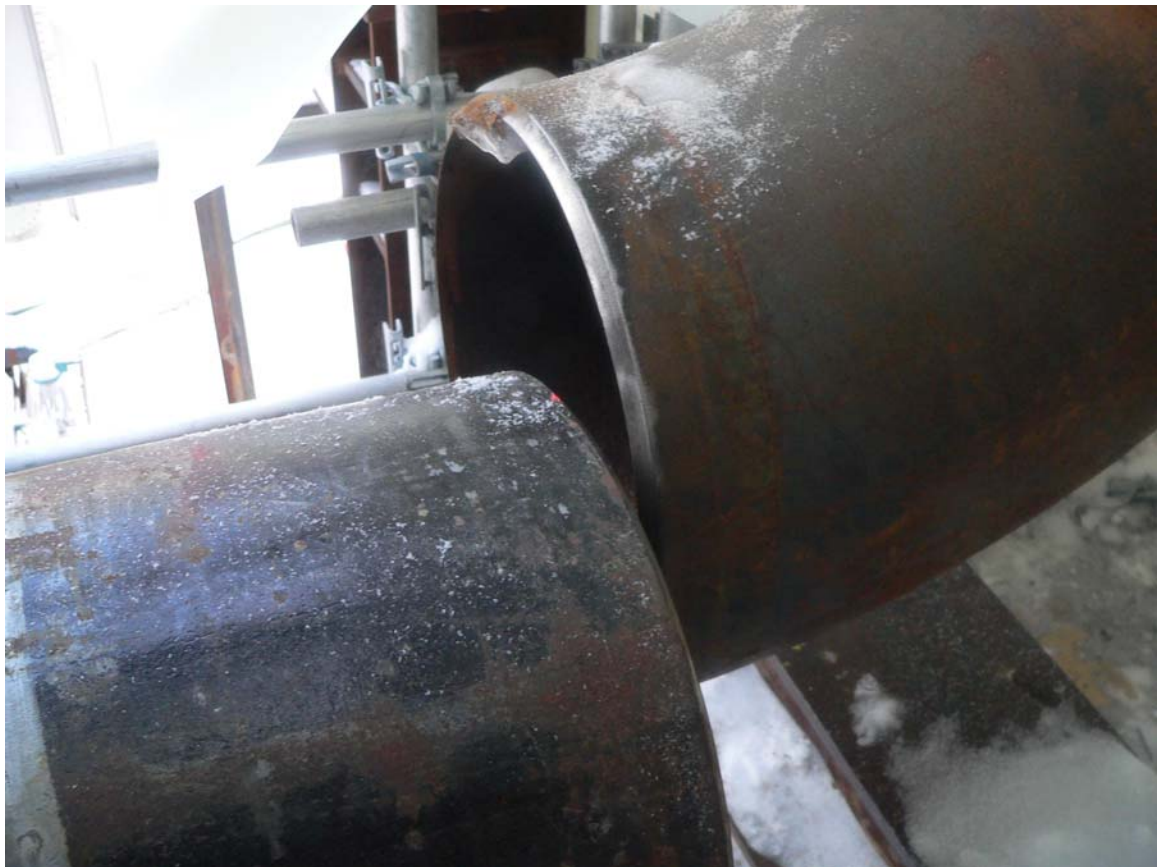
Shows a method of securing shoes referred to as a "U" Clip. These were observed throughout the pipe rack #939. These were not observed in use on the 5 pipe spool involved in the incident.

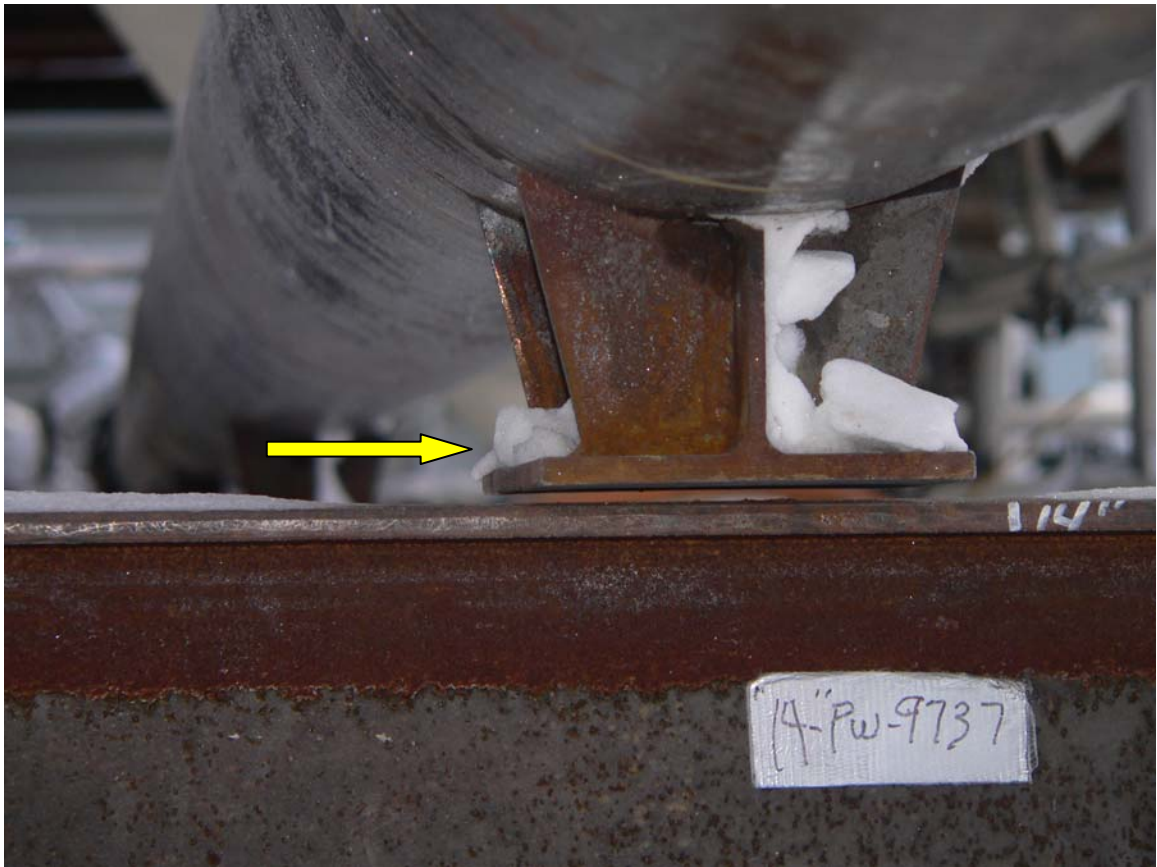
Photograph #13 Shows pipe shoes on existing pipe spools of same diameter with gap (yellow arrow) between the shoe and the supporting I-Beam.
