# Workplace Health and Safety Fatality Report

## **Bus Service Person Trips and Falls**

Type of Incident:        Fatality

Date of Incident:        October 9, 2008

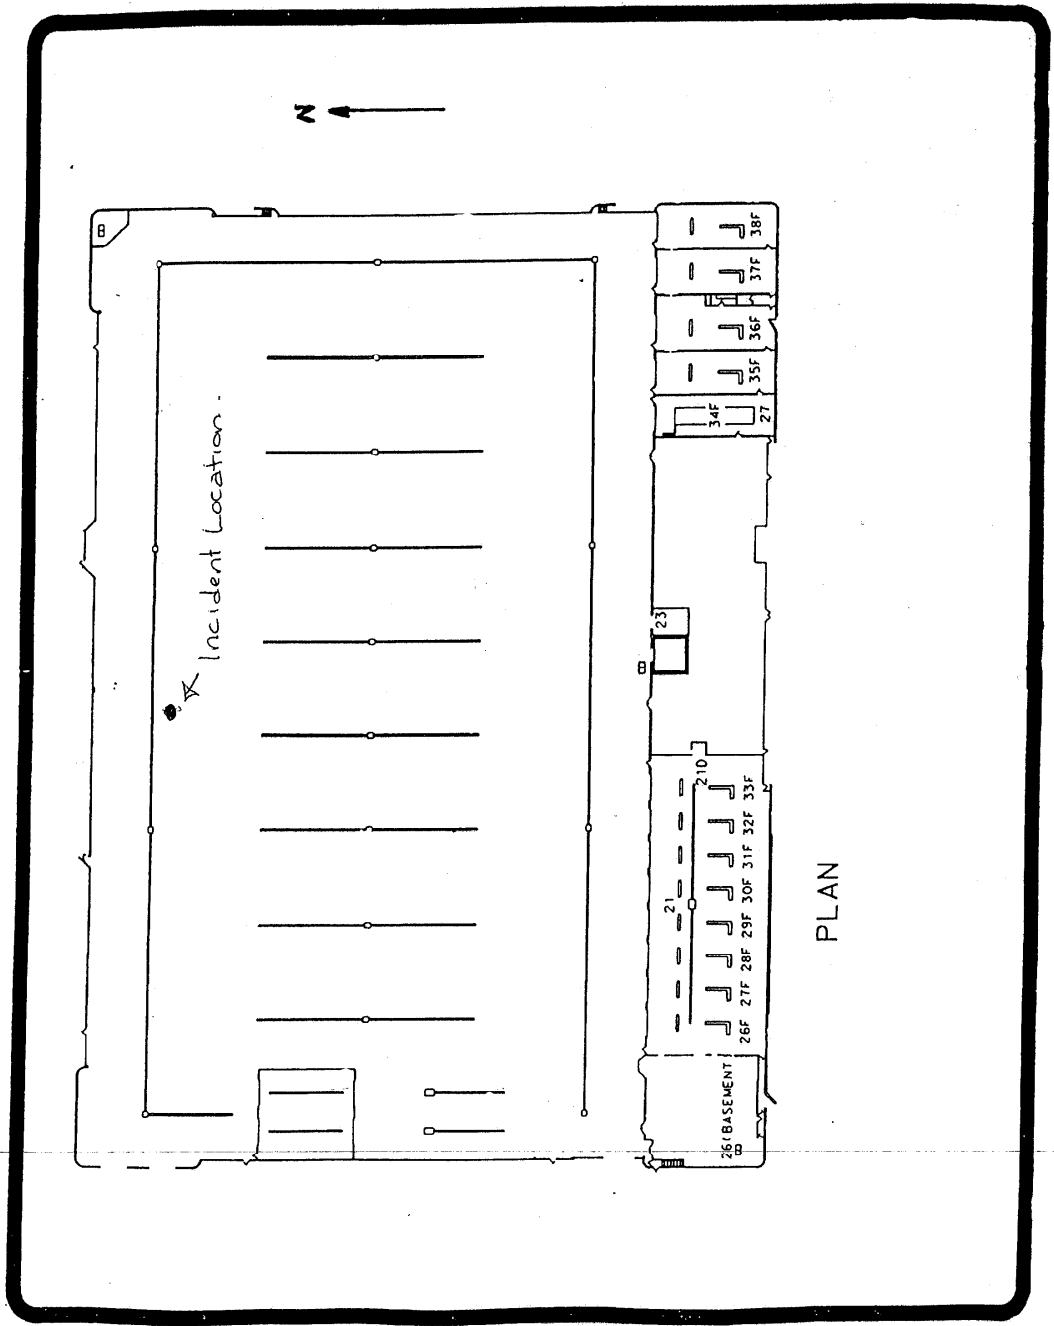
File: F-1008  
Attachment "B" Sketch  
Plan View Of Ferrier Garage Showing Incident Location  
(Not To Scale)

- 5.1.1 The Service Person was parking an Edmonton Transit bus in the inside bus parking area at the Ferrier Garage at the time of the incident. (Attachment B – Diagram) (Attachment C – Photographs #1, #2).

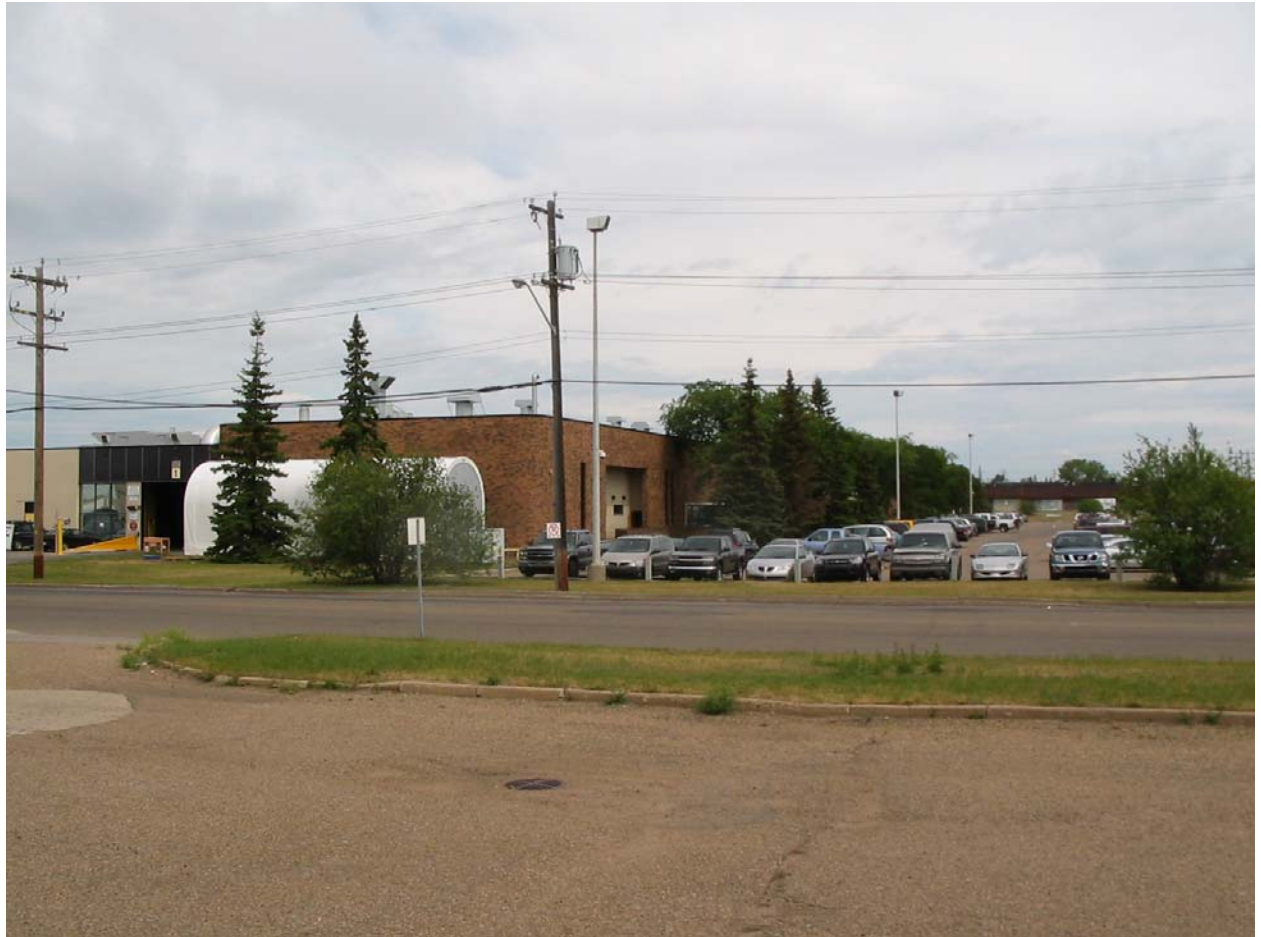
Photograph #1

Shows an external view of the Edmonton Transit Ferrier Garage

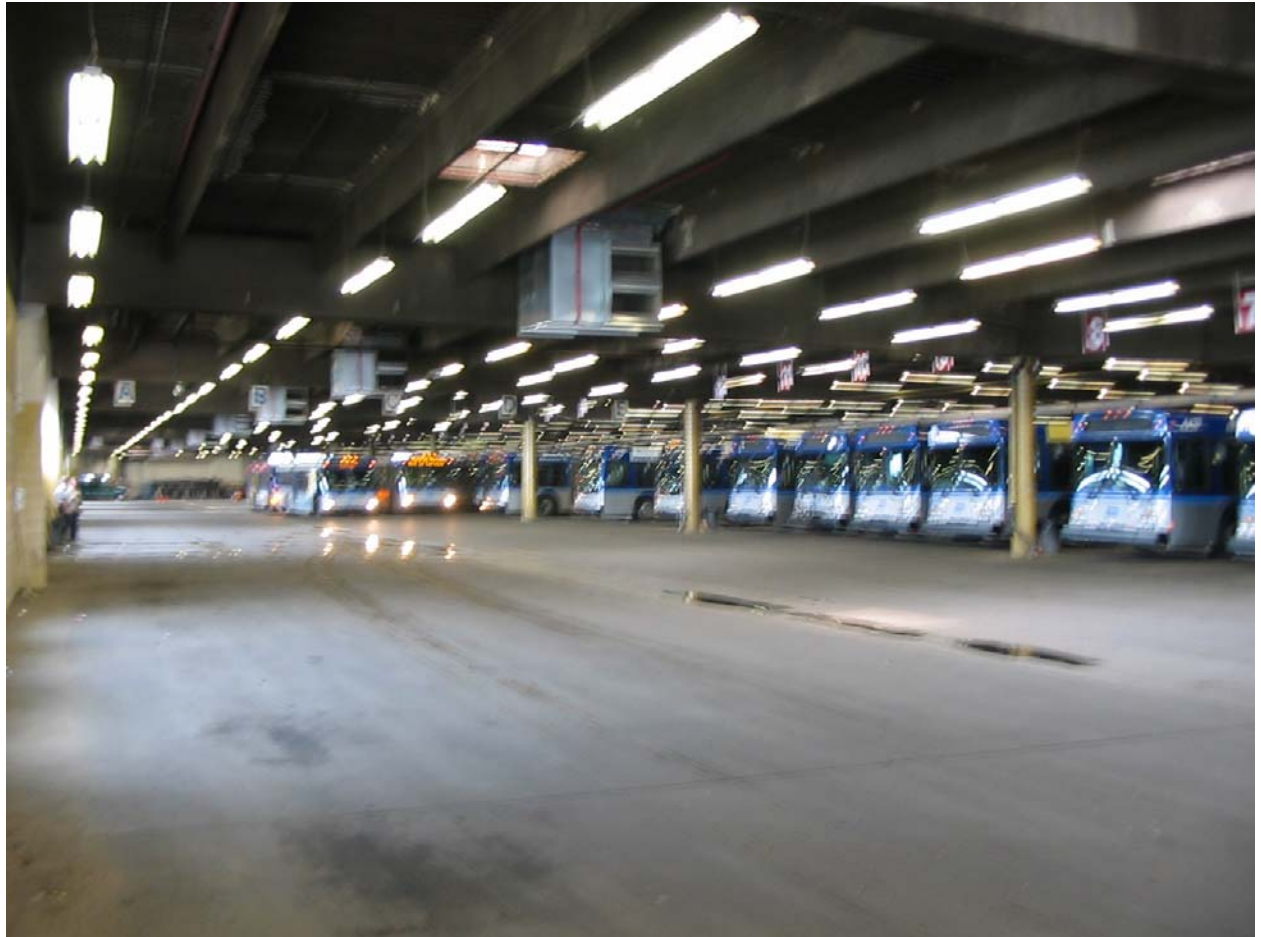
Photograph #2

- 6.4 As the Service Person stepped down from the bus she stepped onto the edge of a steel plate that had been placed over a section of the floor drain that had recently been repaired. The Service Person rolled her ankle and fell to the floor. The Service Person was immediately helped up by the Auto Bodyman Mechanic and placed into a sitting position. The Auto Bodyman Mechanic then went to fetch a golf cart and picked up the Service Person, driving her to the administration offices area of the garage to obtain first aid and assistance.

- 7.1.1 Steel plates placed on the garage floor to cover floor repairs created a potential tripping hazard. The Service Person tripped on the edge of a steel plate and suffered an injury. Her subsequent death from medical complications was not a predictable outcome of the incident.

Shows the inside of the Ferrier Garage. The construction work that was being carried out to the floor in the bus barn had been completed when this photograph was taken.

- 8.2.1 City of Edmonton carried out an incident investigation. Following the incident City of Edmonton placed barricading around the sections of the floor that were covered with steel plates to provide a warning for workers.
- 8.2.2 City of Edmonton moved 25 buses to another location to allow more space for the construction work to take place.
- 8.2.3 A hazard assessment was completed and workers were informed of the hazard at toolbox meetings.
- 8.2.4 A safety alert was issued for distribution to other City of Edmonton locations.
