Workplace Health and Safety Fatality Report

WORKER TRIPS AND FALLS INJURING LEG

Type of Incident: Serious then Fatal

Date of Incident: March 8, 2009

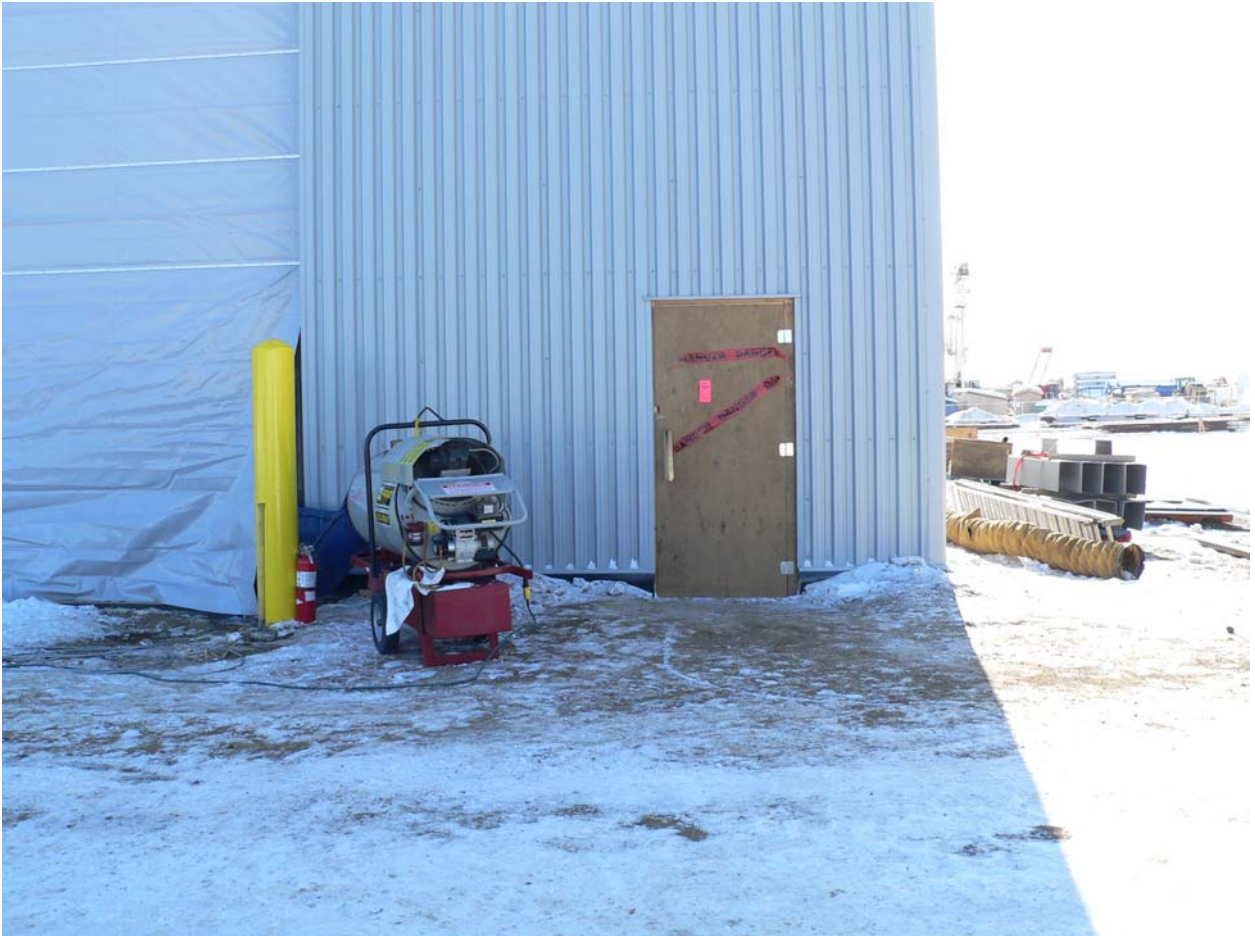
Photograph #1 Shows the man door where the Worker entered the building under construction.

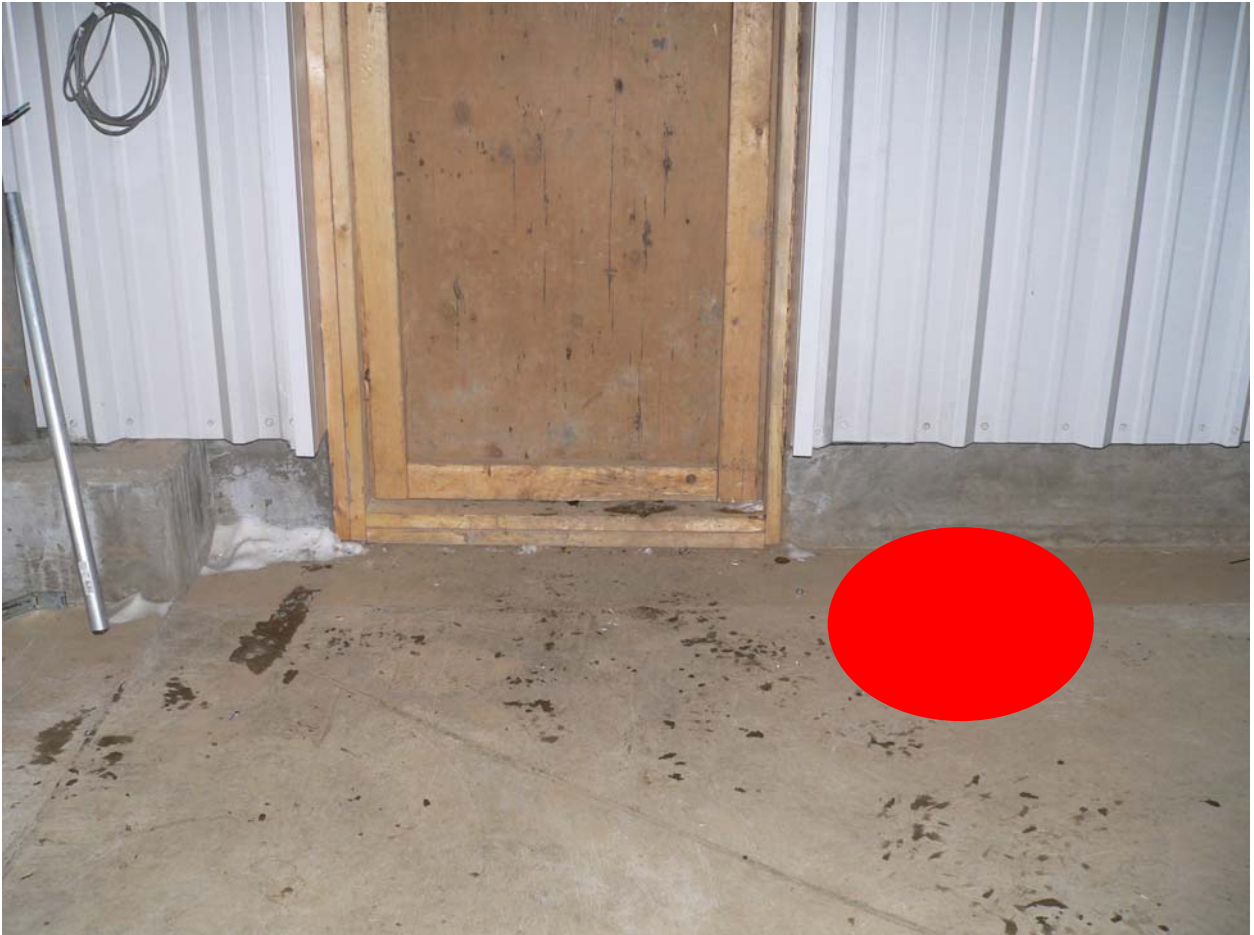
7.1.1 The Worker was seriously injured when he fell and struck the concrete floor with his knees.

7.2.1 The Worker tripped over some electrical technical cable that was being installed at the time.

Photograph #2 Shows the inside of the building where the Worker fell when he entered the man door. There was some electrical tech cable coiled up and off to the side.

The cable was taken away after the incident.

Red circle indicates the approximate area where the tech cable had been coiled up. (Refer to Photograph #3 in reference to the cable.)

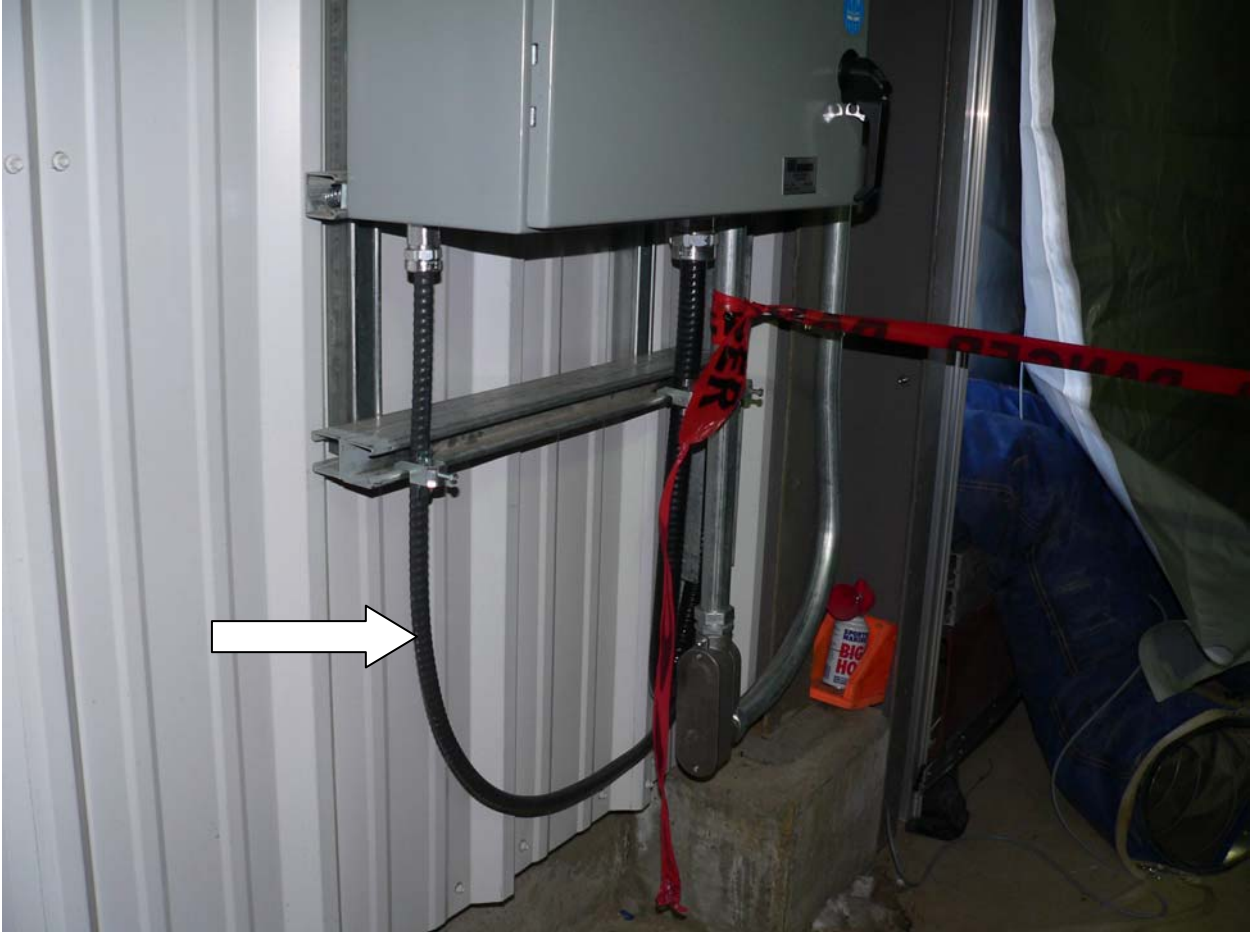
- 5.1.1 The electrical technical cable was coiled up and inside the doorway off to one side. (Attachment "C" Photograph #3)

Photograph #3 Shows the type of black electrical tech cable attached here to the electrical panel that was on the floor near the doorway at the time of the incident.
