# Workplace Health and Safety Fatality Report

## **WORKER FELL OFF A ROOF**

Type of Incident: Fatality

Date of Incident: August 29, 2009

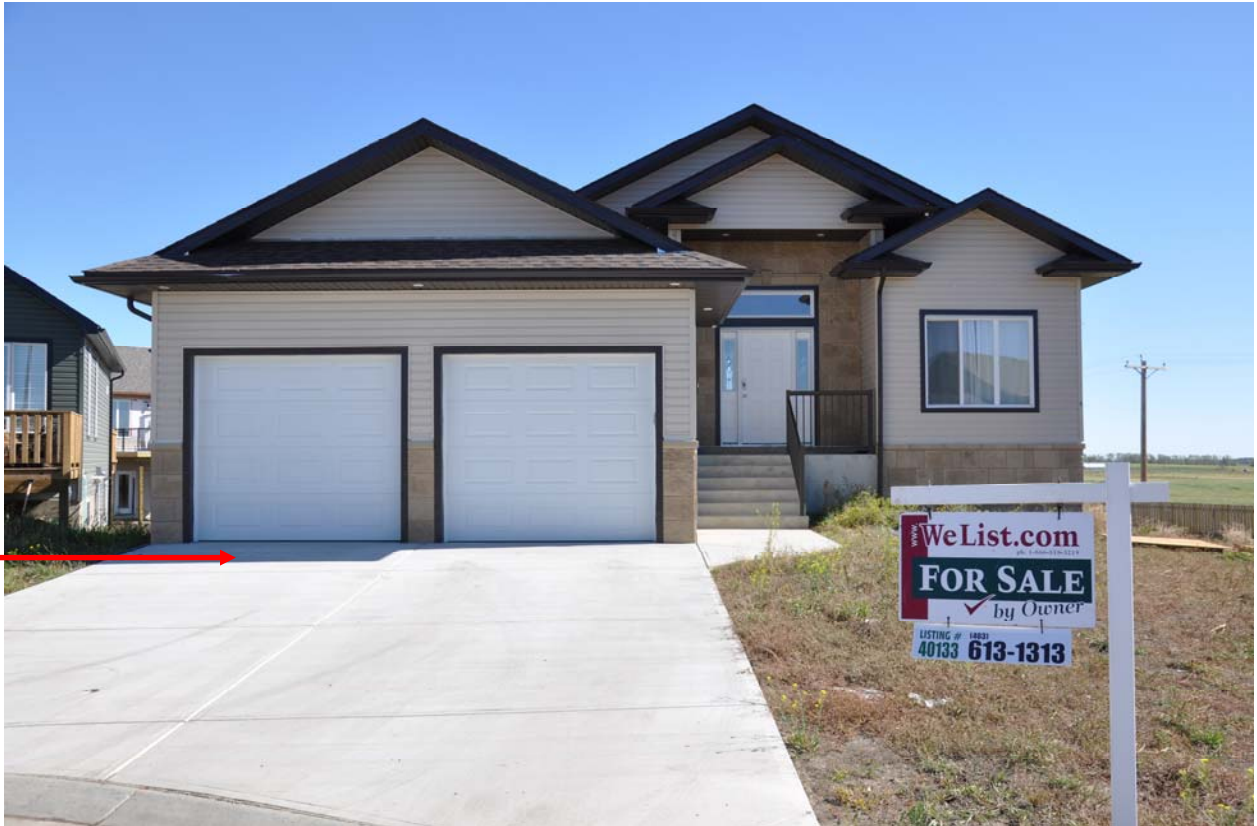
Photograph 1 of 2

Photograph 1: Front view of the house where the incident occurred

Arrow shows the location where the owner landed after he fell

- 7.1.1 The owner was fatally injured when he fell approximately 3.4 meters from the roof onto the concrete drive way.

- 7.2.1 The owner was not using a fall protection system.
- 7.2.2 No hazard assessment was conducted prior to starting work on the roof.

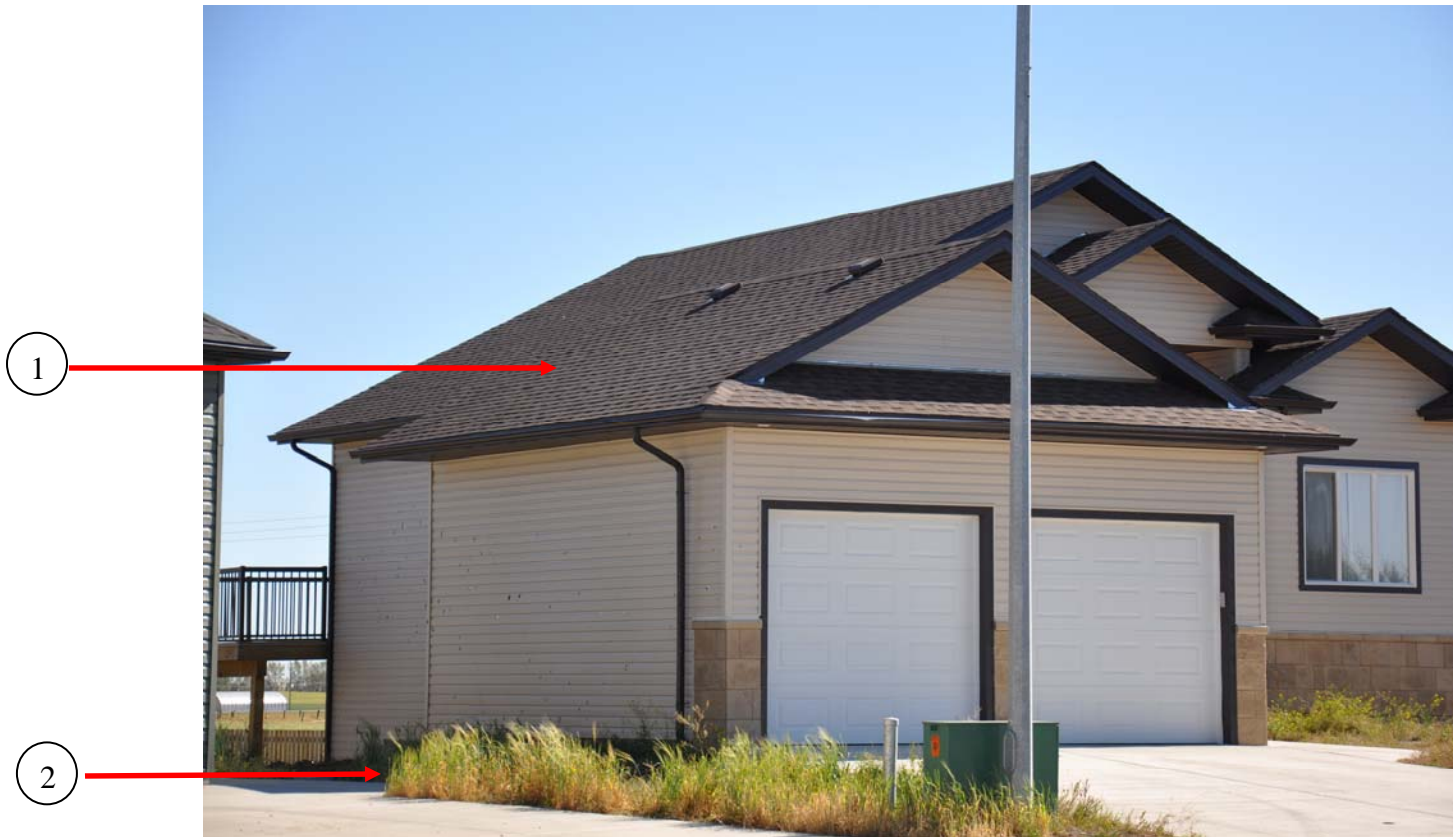
Photograph 2 of 2

Photograph 2: This photograph was taken after the roofing job was completed

1. Shows the garage roof where the owner and worker 1 were removing hail damaged shingles
2. Shows the location where the bin was located

- 5.1.1 The workers were replacing hail damaged shingles on the roof. The removed hail damaged shingles were discarded into a bin located on the ground beside the garage (Refer to Attachment B- Photographs 1 and 2).
- 5.1.2 The owner and the workers were not using a fall protection system.
