# Workplace Health and Safety Fatality Report

## **Bus Service Person Trips and Falls**

Type of Incident:        Fatality

Date of Incident:        October 9, 2008

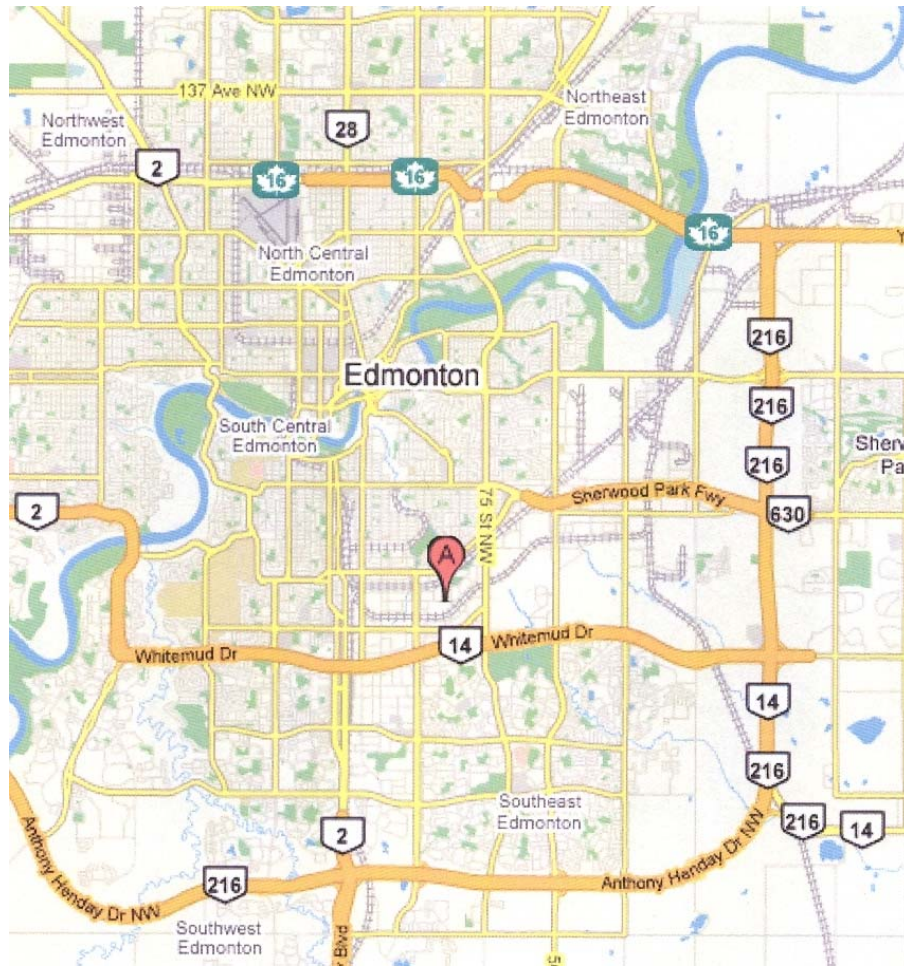
File: F-1008  
Attachment "B" Sketch  
Plan View Of Ferrier Garage Showing Incident Location  
(Not To Scale)

- 6.4 As the Service Person stepped down from the bus she stepped onto the edge of a steel plate that had been placed over a section of the floor drain that had recently been repaired. The Service Person rolled her ankle and fell to the floor. The Service Person was immediately helped up by the Auto Bodyman Mechanic and placed into a sitting position. The Auto Bodyman Mechanic then went to fetch a golf cart and picked up the Service Person, driving her to the administration offices area of the garage to obtain first aid and assistance.

- 7.1.1 Steel plates placed on the garage floor to cover floor repairs created a potential tripping hazard. The Service Person tripped on the edge of a steel plate and suffered an injury. Her subsequent death from medical complications was not a predictable outcome of the incident.

- 8.2.1 City of Edmonton carried out an incident investigation. Following the incident City of Edmonton placed barricading around the sections of the floor that were covered with steel plates to provide a warning for workers.
- 8.2.2 City of Edmonton moved 25 buses to another location to allow more space for the construction work to take place.
- 8.2.3 A hazard assessment was completed and workers were informed of the hazard at toolbox meetings.
- 8.2.4 A safety alert was issued for distribution to other City of Edmonton locations.
